Contract No. DC/2007/24
Harbour Area Treatment
Scheme Stage 2A -
Construction of Sewage
Conveyance System from
Aberdeen to Sai Ying Pun:
*Baseline Landscape & Visual
Monitoring Report*

March 2010

Environmental Resources Management

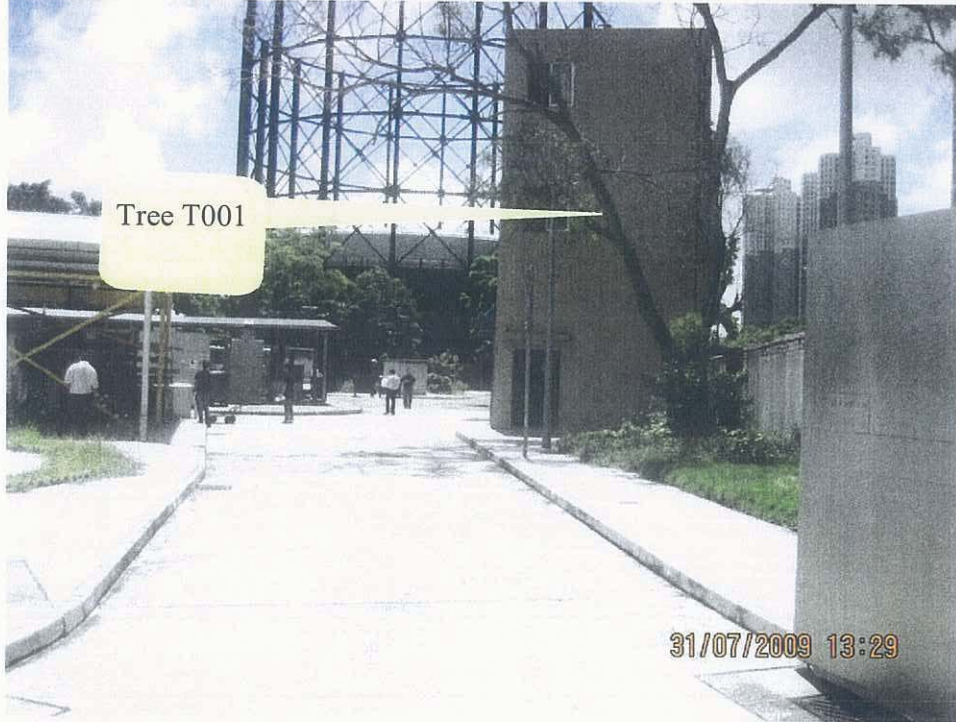
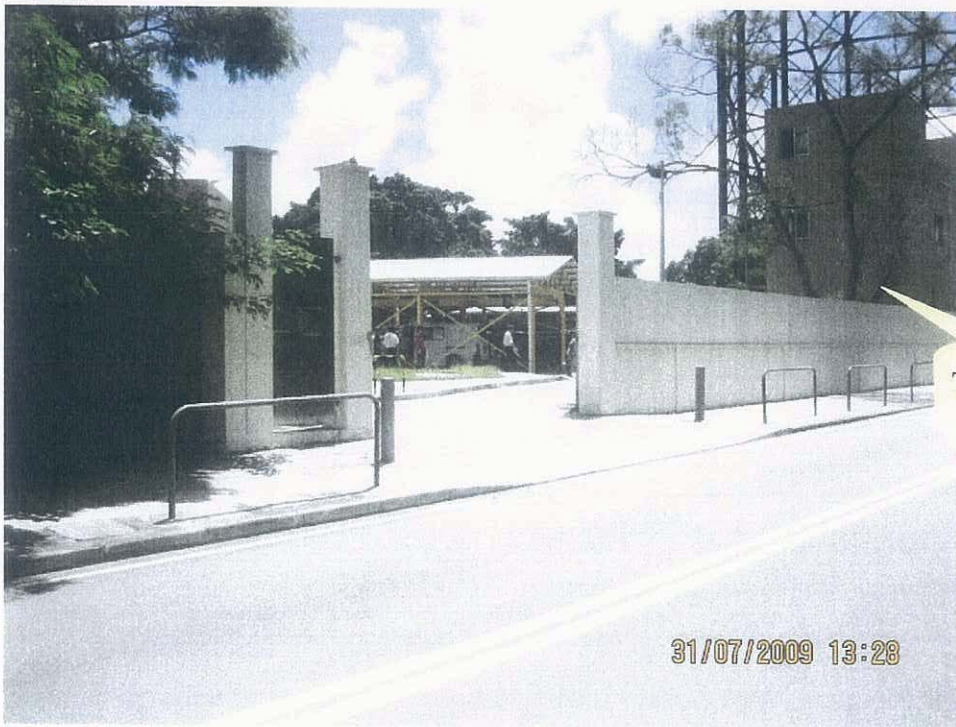
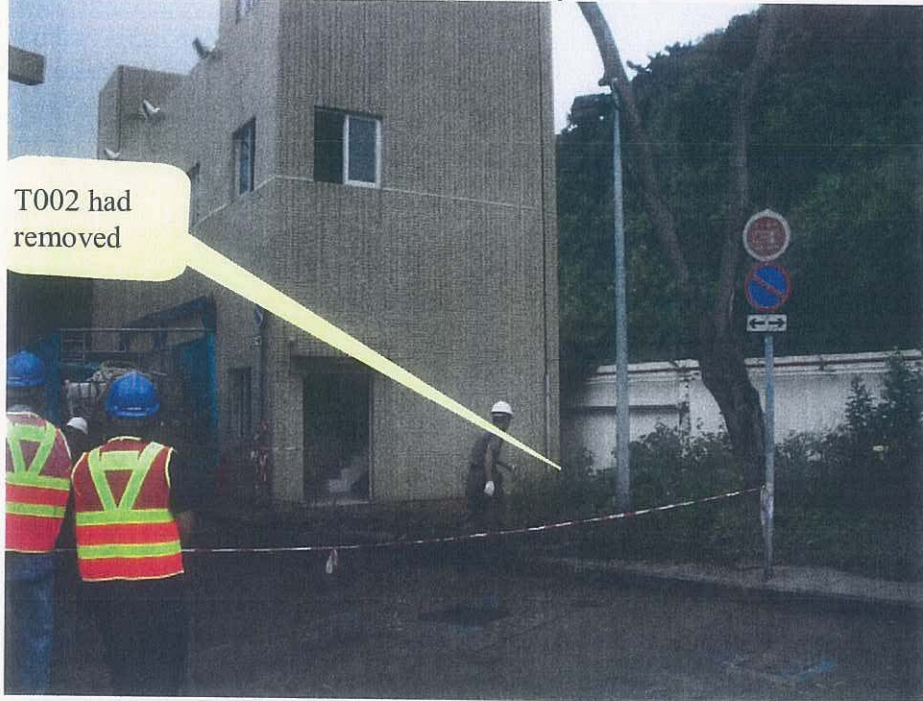
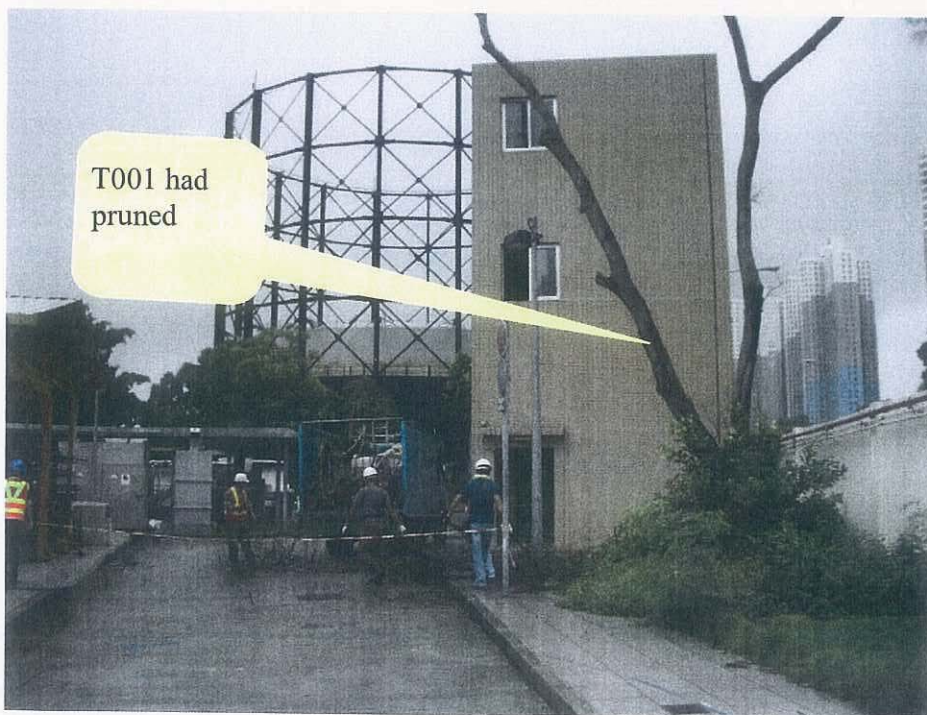
Aberdeen PTW – Tree remove and pruned by DSD ST2

We write to record that the trees located in Aberdeen PTW no. T001 and T002 as shown on the attachment had been pruned and removed respectively by Drainage Sewage Department Sewage Treatment 2 Division on 16 September after Typhoon Signal no.8 on 14 September 2009.

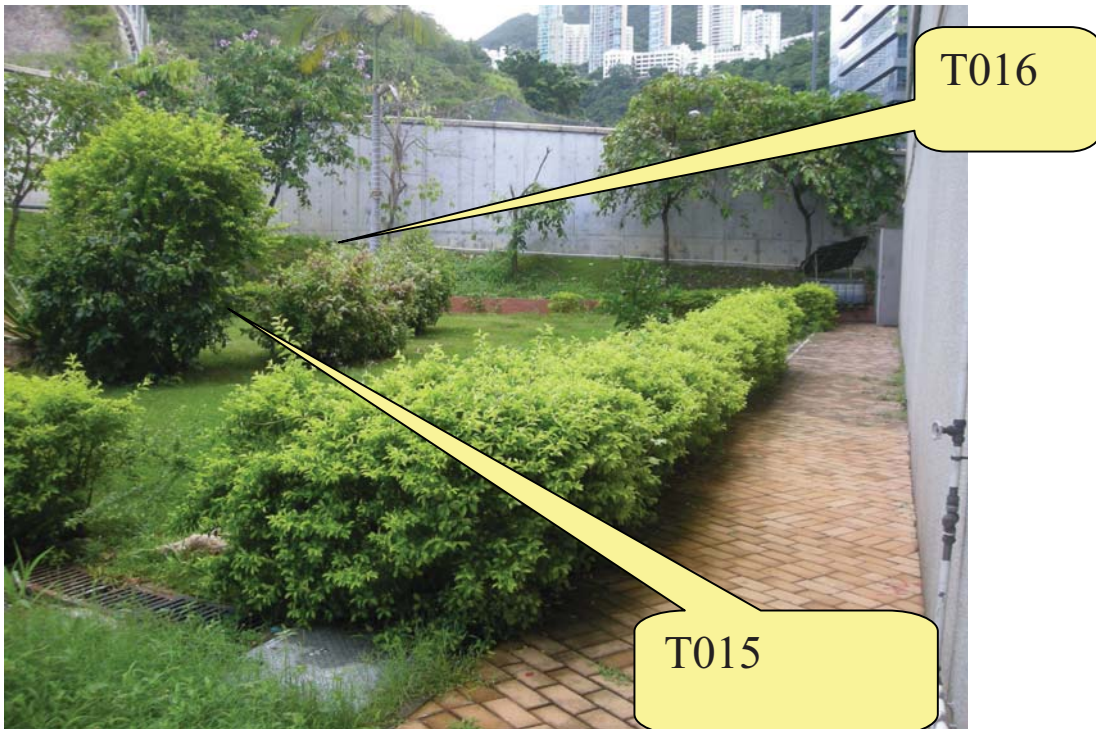
Refer to the joint inspection between your staff Mr. Sam Yan, Mr. Paul Tang, Mr. Stephen Chan and our Mr. T.W. Lam on 9th October 2009. We would like to report that there are 2 trees in Cyberport PTW and 1 tree in Aberdeen site portion Abd-iiiia were found missing. Also 1 tree was found cut by other in Aberdeen PTW.

Cyberport PTW – T015(T) & T016(T) were missing

Two trees were identified as missing at each of LR5 and LR7 and 1 dead tree was identified at LR7. The compensation of the above-mentioned missing trees is under discussion with DLO. Should compensatory tree planting be required confirmed by DLO, same or compatible species will be adopted and the number will have equal aggregate trunk diameter to the aggregate trunk diameter lost by the above-mentioned missing/dead trees.

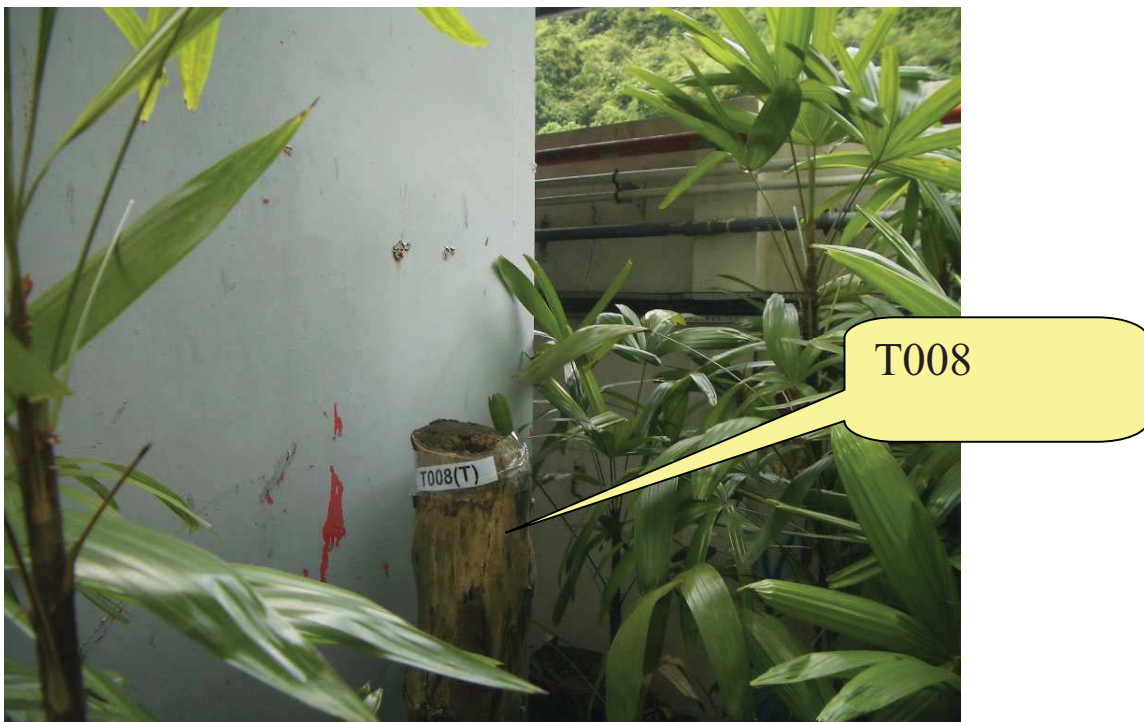
Aberdeen PTW – T008(T) Cut by other

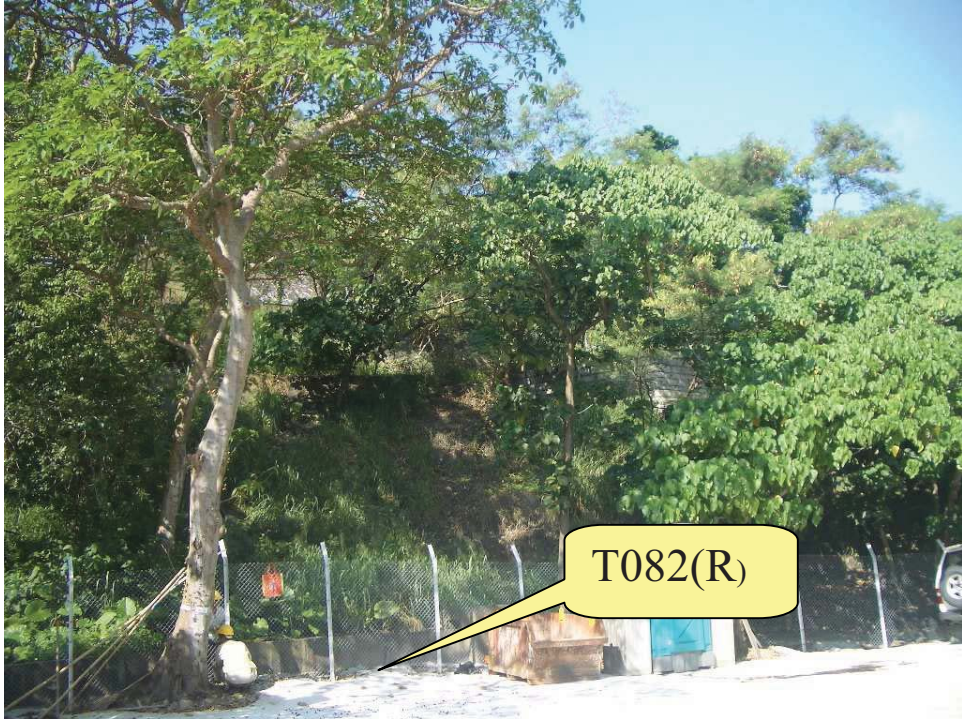
Aberdeen Abd-iiia – T082(R) was found missing
