**Landscape and Visual (L&V) Monitoring Report for
Harbour Area Treatment Scheme Stage 2A
(Operational Phase) (April 2022)**

Report No.: OT_2022005

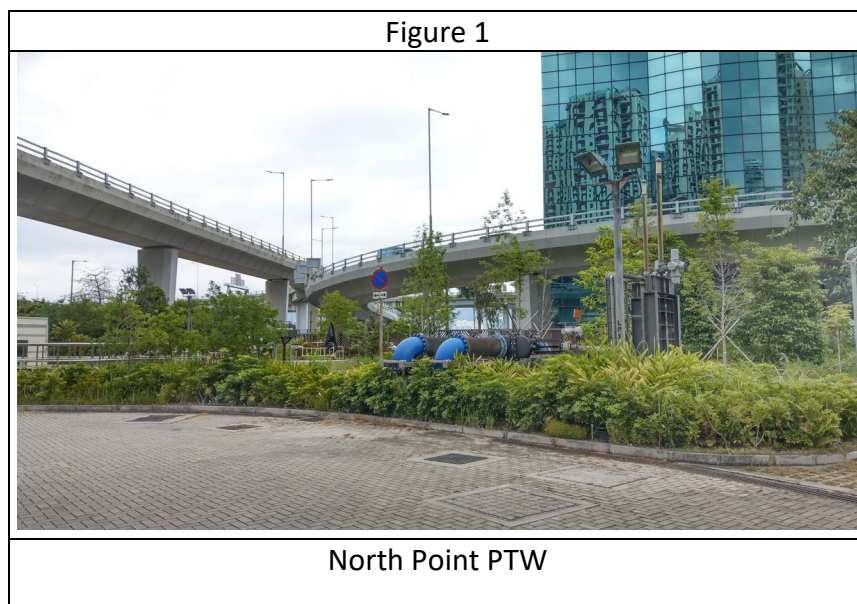
- No visible irregularities were found

- Contractor was reminded to carry out proper maintenance to plantings and was recommended to increase the frequency of watering.

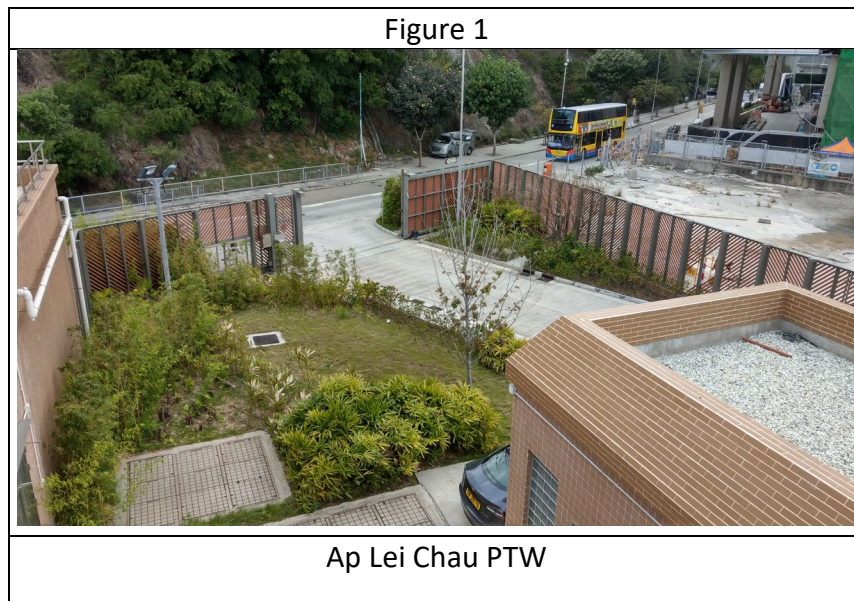
- No visible irregularities were found

- Contractor was reminded to carry out proper maintenance to plantings and recommended to increase the frequency of watering.

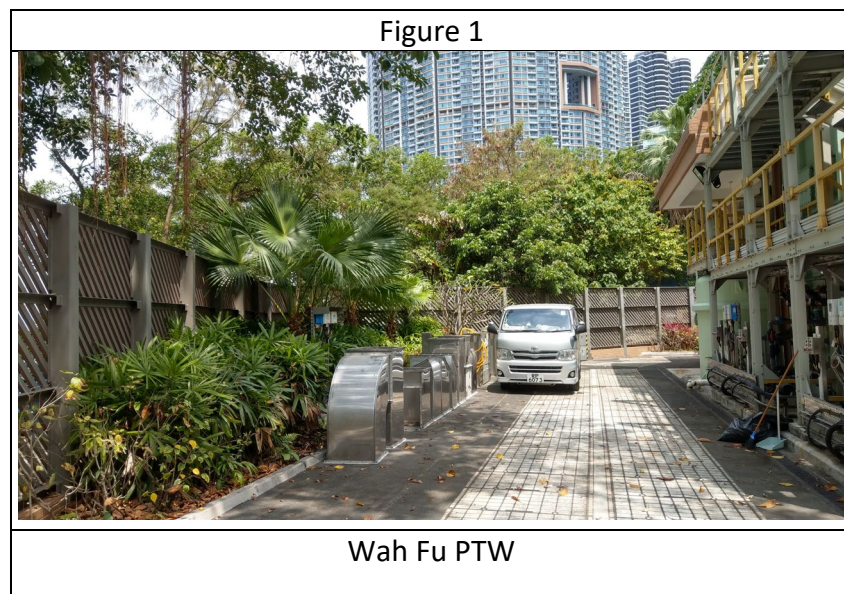
- No visible irregularities were found

- Contractor was reminded to carry out proper maintenance to plantings and recommended to increase the frequency of watering.

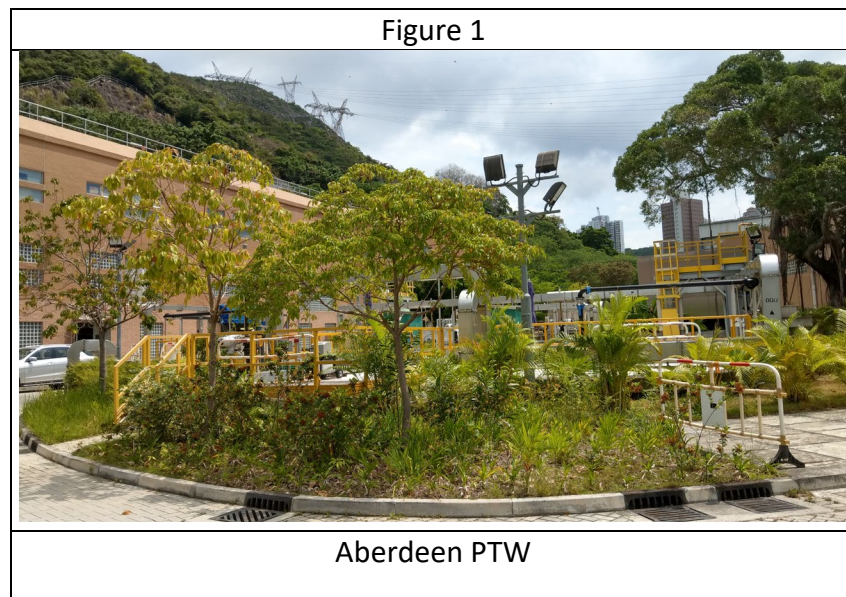
- No visible irregularities were found

- Contractor was reminded to carry out proper maintenance to plantings and recommended to closely monitor the conditions of the pruned trees. It is also recommended to increase the frequency of watering.

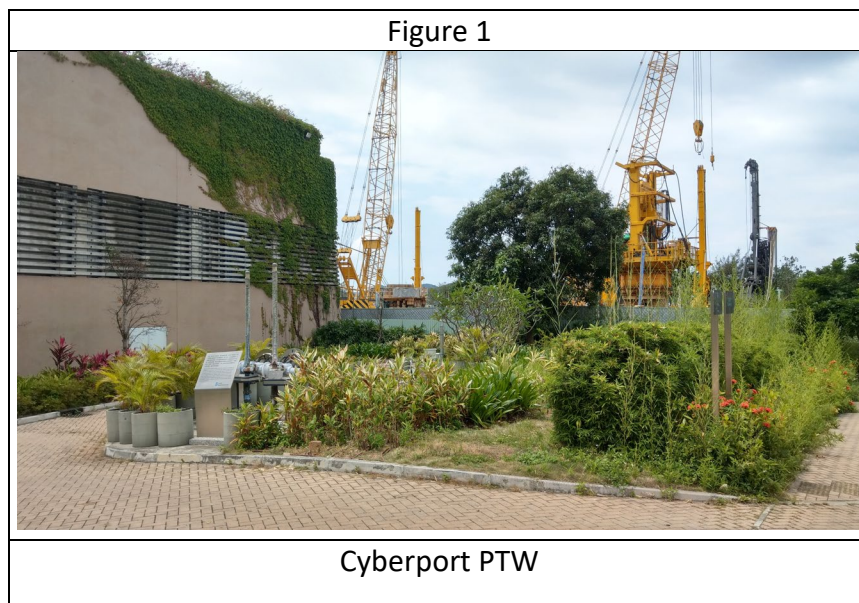
- No visible irregularities were found

- Contractor was reminded to carry out proper maintenance to plantings and removal of weeds. It is also recommended to increase the frequency of watering and apply fertilizer periodically.

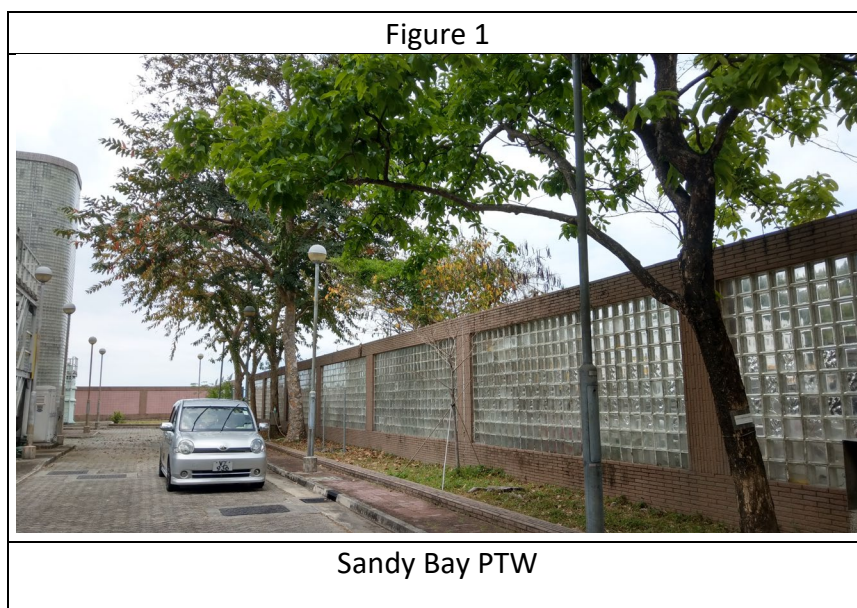
- No visible irregularities were found

- Contractor was reminded to carry out proper maintenance to plantings and recommended to increase the frequency of watering.

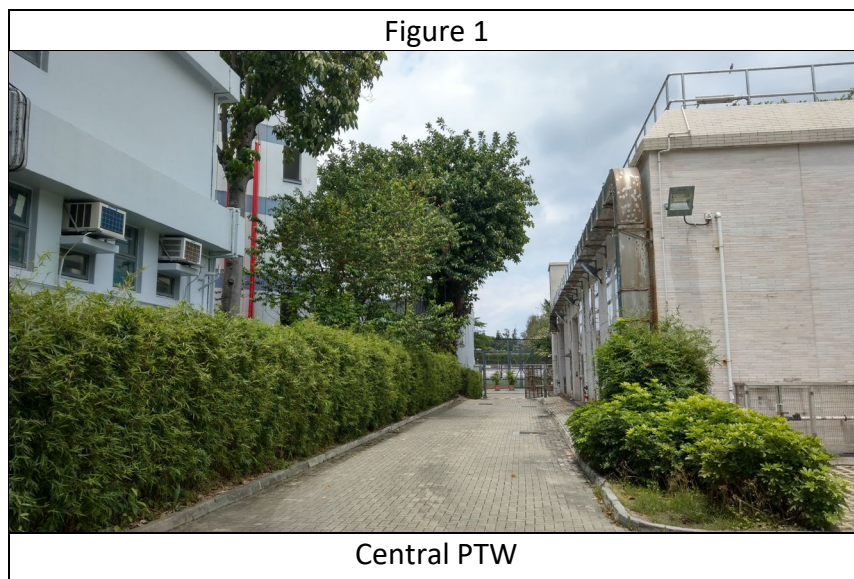
- No visible irregularities were found

- Contractor was reminded to carry out proper maintenance to plantings.

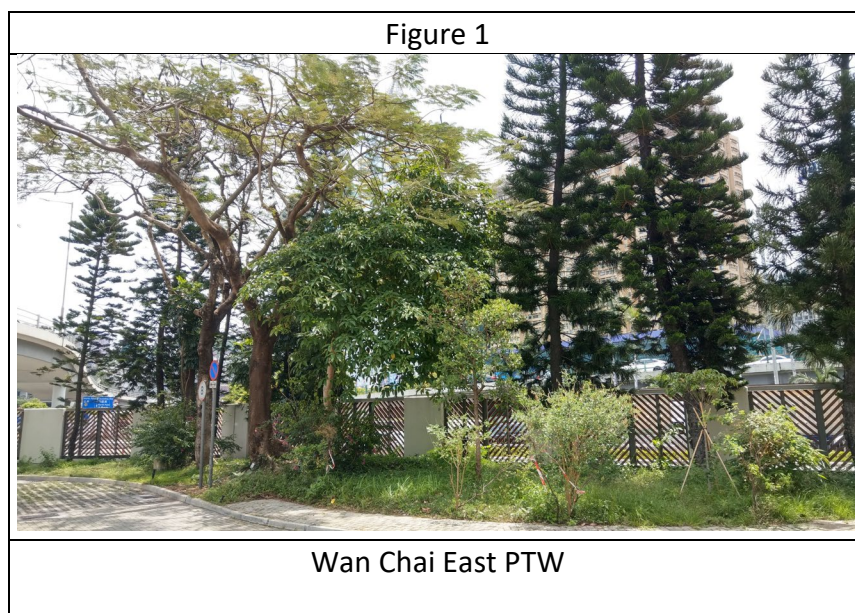
- No visible irregularities were found

- Contractor was reminded to carry out proper maintenance to plantings and recommended to provide adequate protection to trees adjacent to works area.

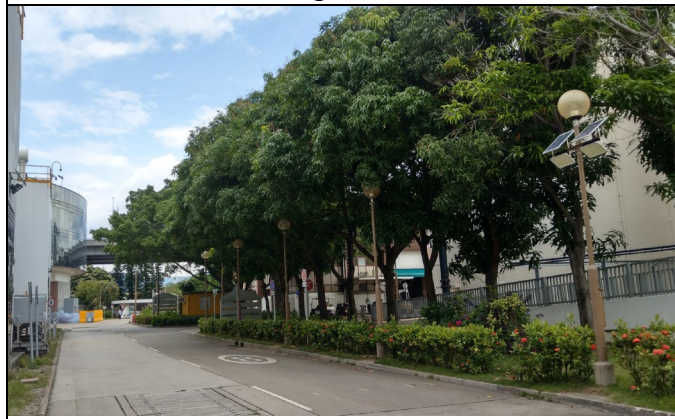
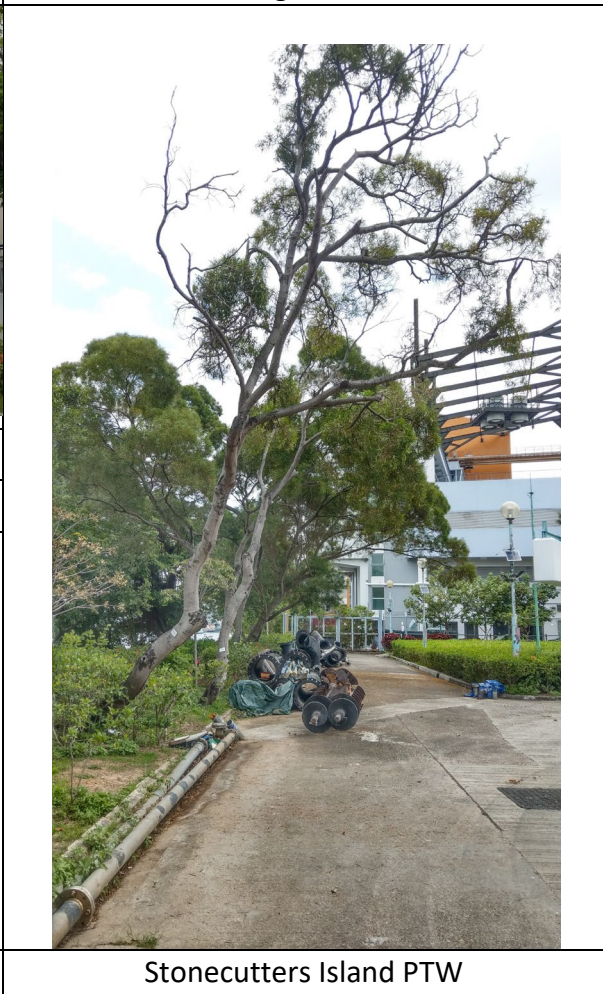
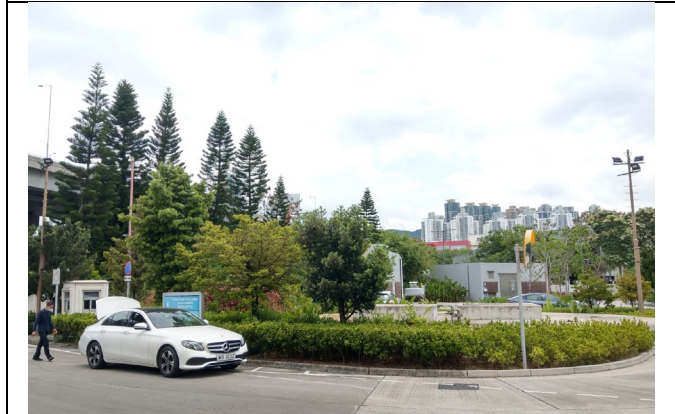
3.2.2. Dead foliage was found in some trees/shrubs at SCISTW. It is recommended to carry out horticultural maintenance. Besides, the vigor of some existing trees (e.g. T110) were found in poor condition and an increase on frequency of tree inspection or risk assessment may be required.

- dead foliage are found in some trees/shrubs. horticultural maintenance is required.
- vigour of some existing trees (e.g.T110) are found to be poor. close monitoring or tree risk assessment may be required.
