**Landscape and Visual (L&V) Monitoring Report for
Harbour Area Treatment Scheme Stage 2A
(Operational Phase) (August 2022)**

Report No.: OT_2022011

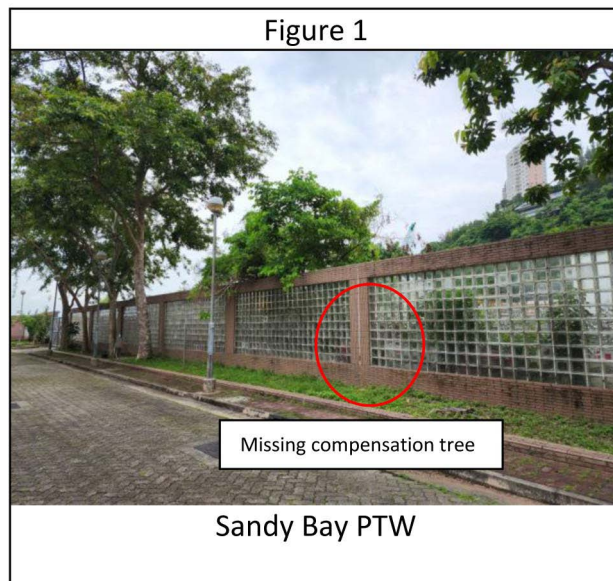
1. Follow up rectification item no.1 on 29/07/2022, the marked tree was removed but the compensation tree is missing. The Contractor is reminded to carry out tree replacement.

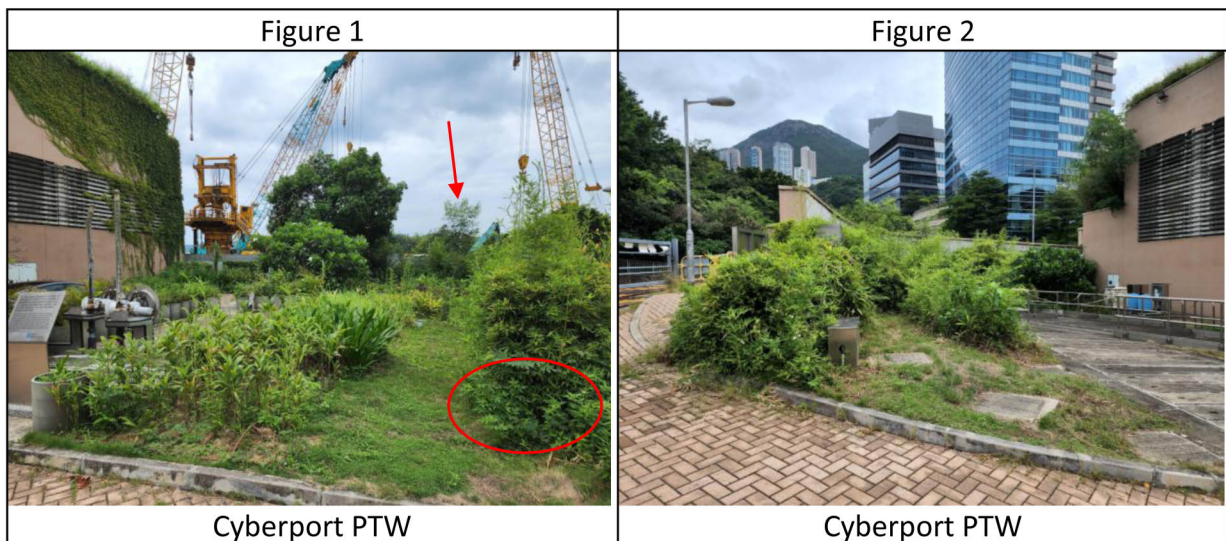
1. Weeds and undesirable species (*Leucaena leucocephala*) were observed among shrubs planting. It is recommended to carry out necessary weeding and maintenance work.

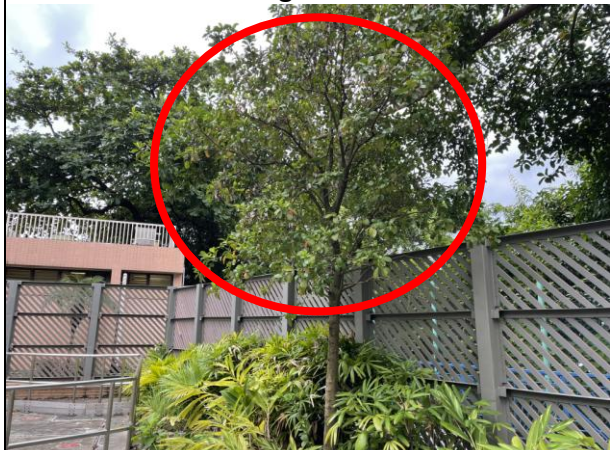
<p>Wah Fu PTW</p>	<p>Wah Fu PTW</p>
<p>Figure 3</p>

1. Dead leaves were observed at the marked tree (as shown in Figure 3). It is recommended that maintenance party to review if pruning is required.

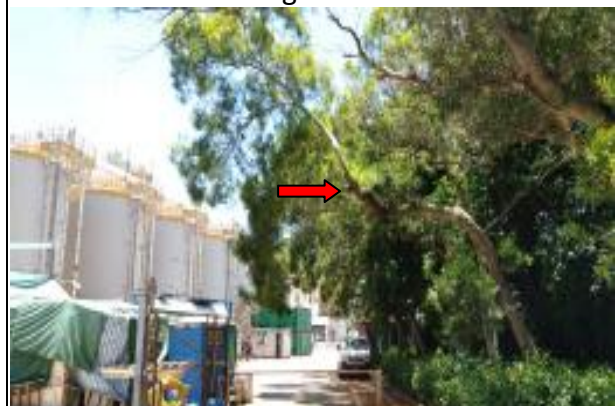
<p style="text-align: center;">Stonecutters Island STW</p>
<p style="text-align: center;">Figure 3</p>

1. Some existing trees adjacent to T110 & T109 are still found severely tilted and span over driveway (shown in Figure 3). It is recommended that maintenance party to review if pruning is required.
