**Landscape and Visual Monitoring Report (February 2022) for Harbour Area Treatment Scheme Stage 2A (Operational Phase)**

**Landscape and Visual (L&V) Monitoring Report for  
Harbour Area Treatment Scheme Stage 2A  
(Operational Phase) (February 2022)**

Report No.: OT\_2022003

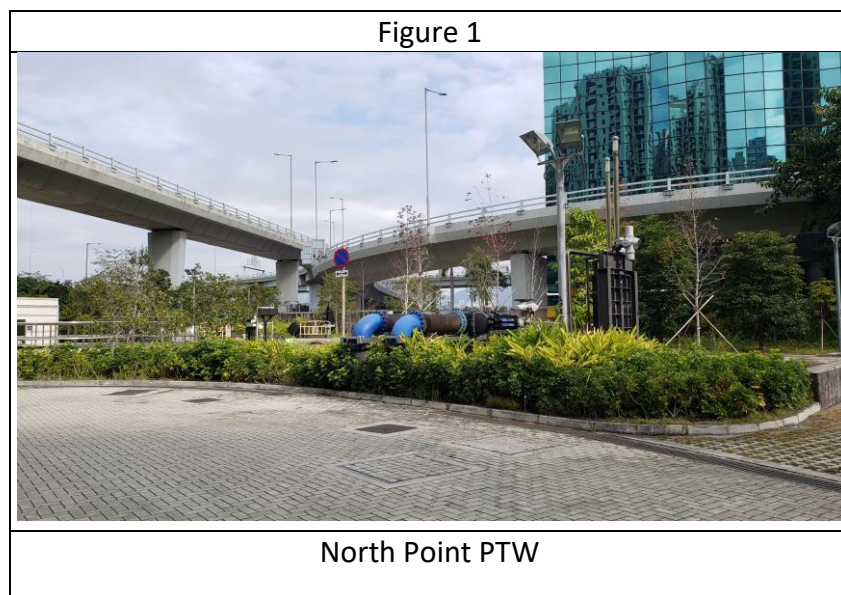
**Photo Record:**

- No visible irregularities were found

- Contractor was reminded to carry out proper maintenance to plantings and recommended to increase the frequency of watering.

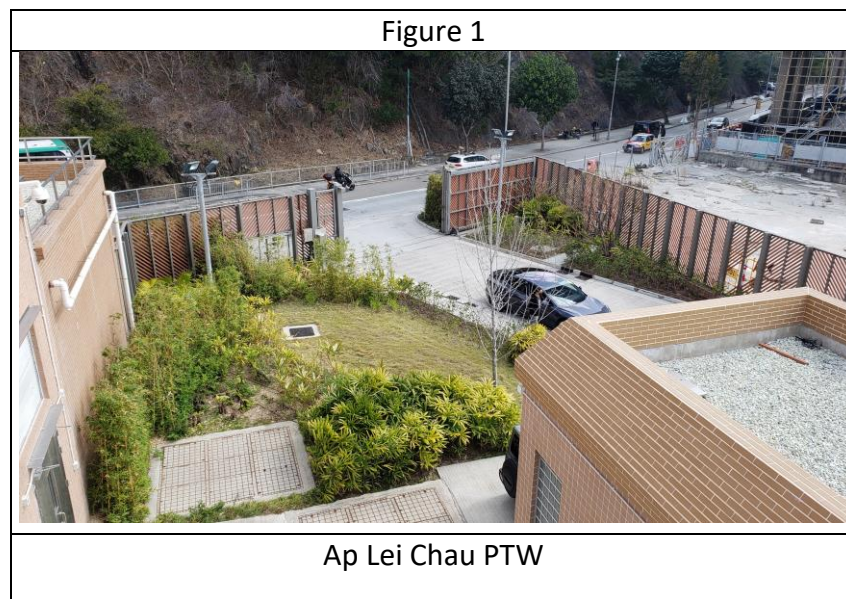
**Photo Record:**

- No visible irregularities were found

- Contractor was reminded to carry out proper maintenance to plantings and recommended to increase the frequency of watering.

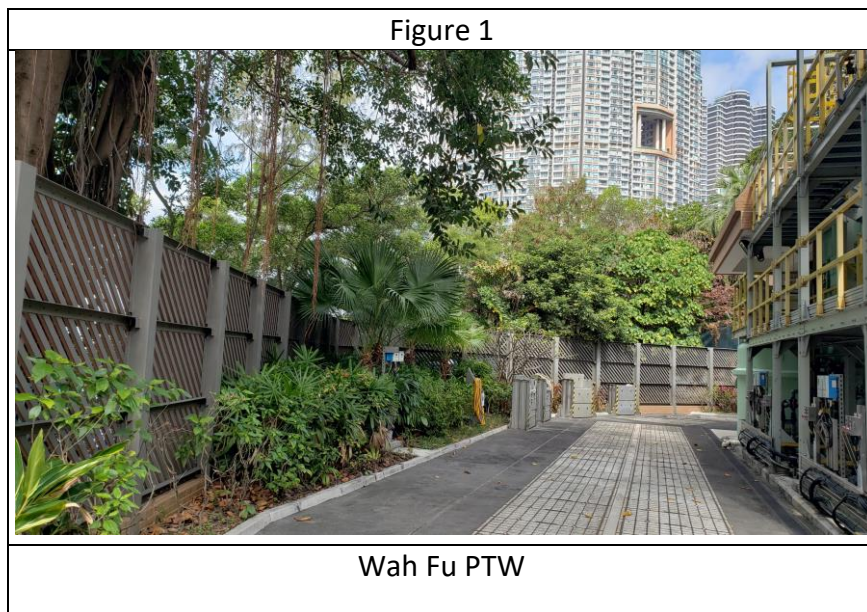
**Photo Record:**

- No visible irregularities were found

- Contractor was reminded to carry out proper maintenance to plantings.

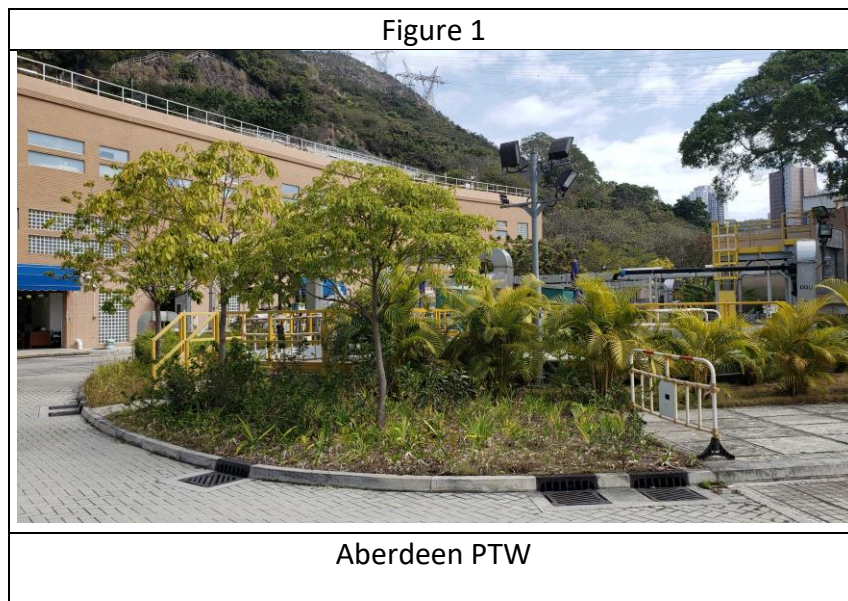
**Photo Record:**

- No visible irregularities were found

- Contractor was reminded to carry out proper maintenance to plantings and recommended to increase the frequency of watering.

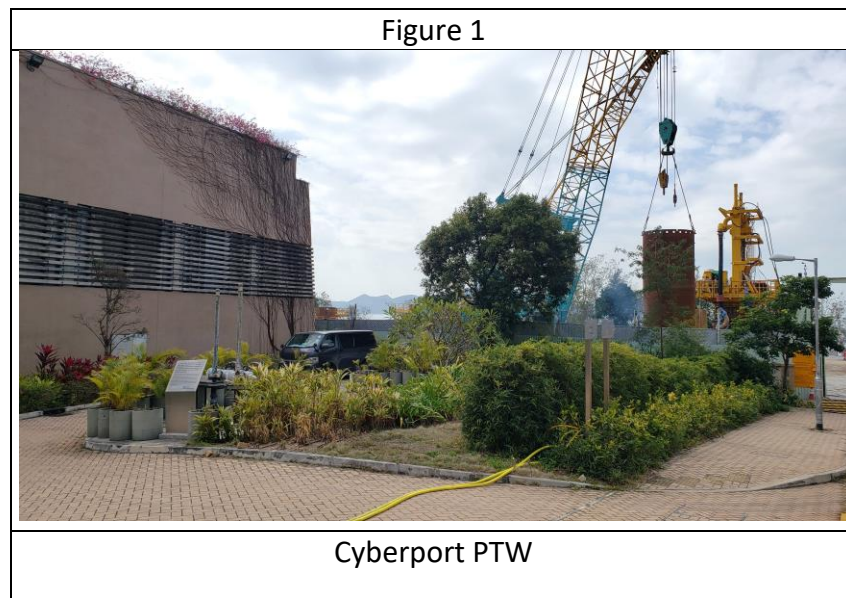
**Photo Record:**

- No visible irregularities were found

- Contractor was reminded to carry out proper maintenance to plantings.

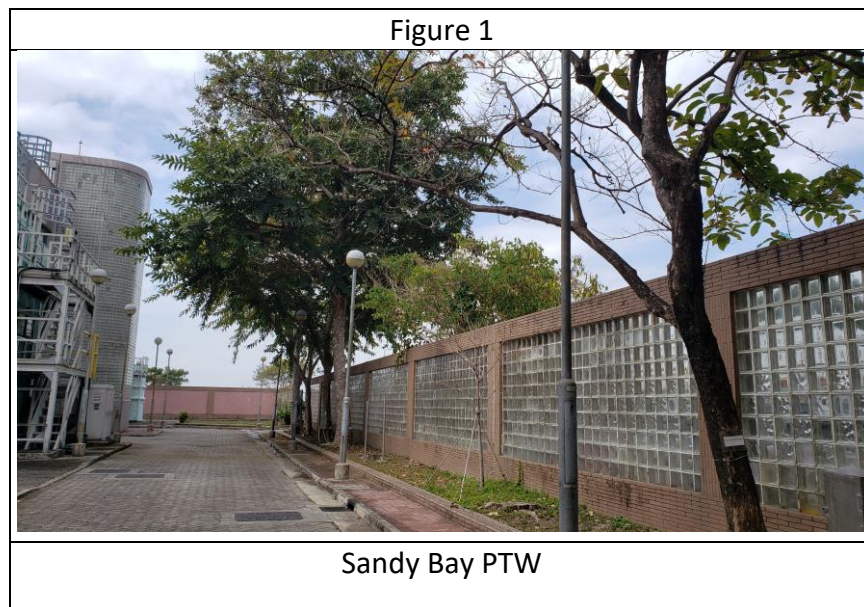
**Photo Record:**

- No visible irregularities were found

- Contractor was reminded to carry out proper maintenance to plantings.

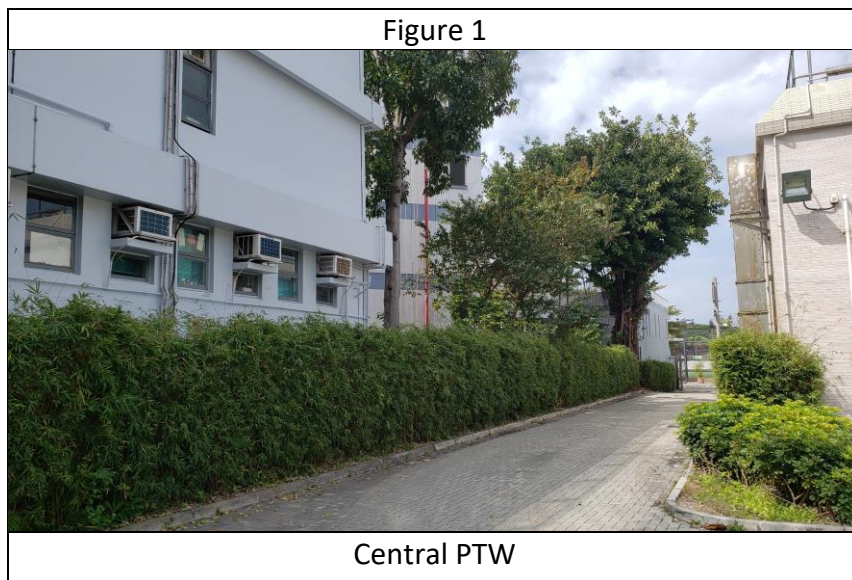
**Photo Record:**

- No visible irregularities were found

- Contractor was reminded to carry out proper maintenance to plantings.

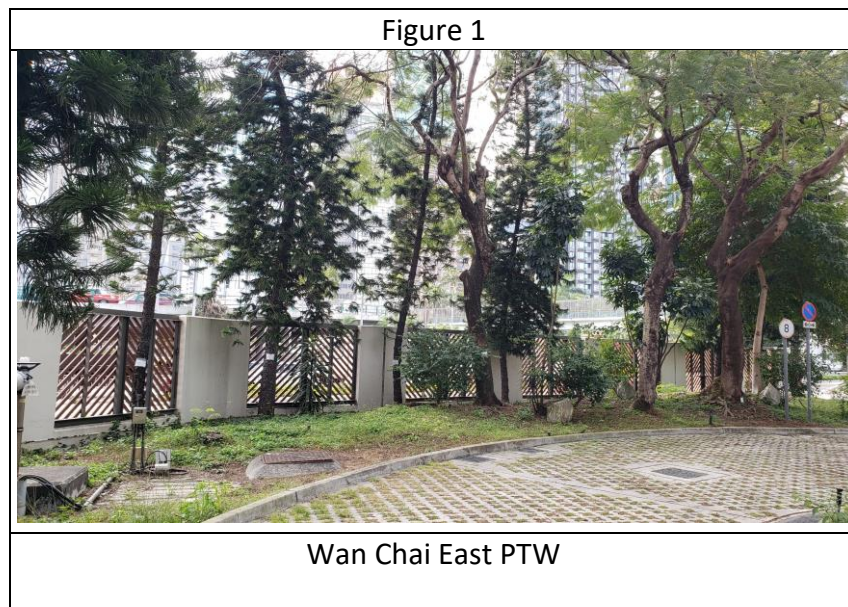
**Photo Record:**

- No visible irregularities were found

- Contractor was reminded to carry out proper maintenance to plantings.

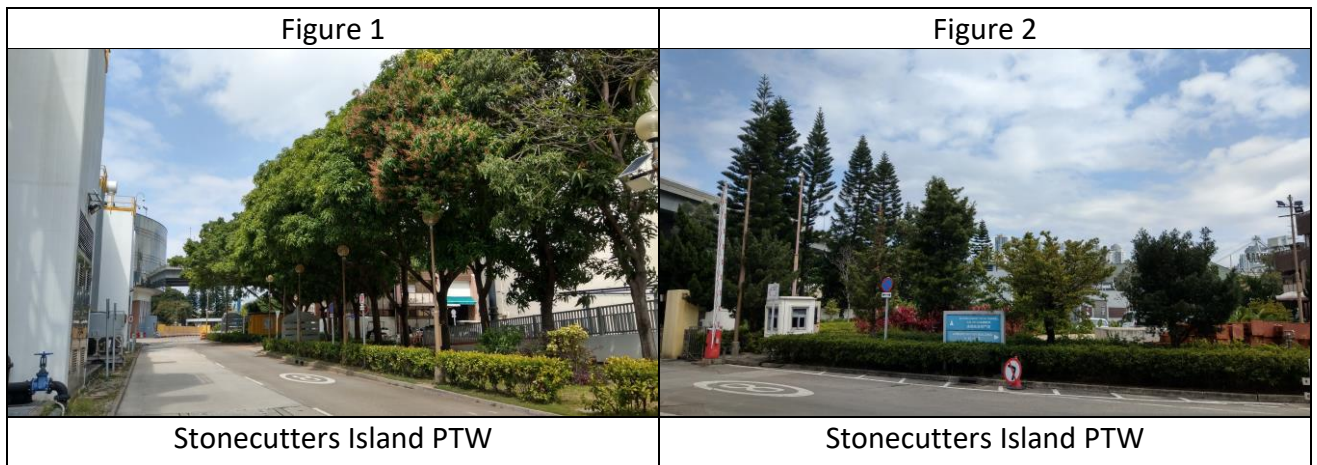
**Photo Record:**

- No visible irregularities were found

- Contractor was reminded to carry out proper maintenance to plantings.
