Landscape and Visual Monitoring Report (January 2022) for Harbour Area Treatment Scheme Stage 2A (Operational Phase)

**Landscape and Visual (L&V) Monitoring Report for
Harbour Area Treatment Scheme Stage 2A
(Operational Phase) (January 2022)**

Report No.: OT_2022002

**Enhancement of Deodourisation System at Stonecutters Island
Sewage Treatment Works**

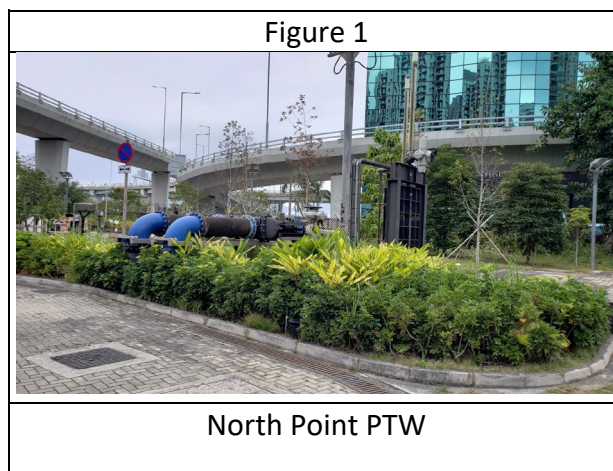
- No visible irregularities were found

- Contractor was reminded to carry out proper maintenance to plantings.

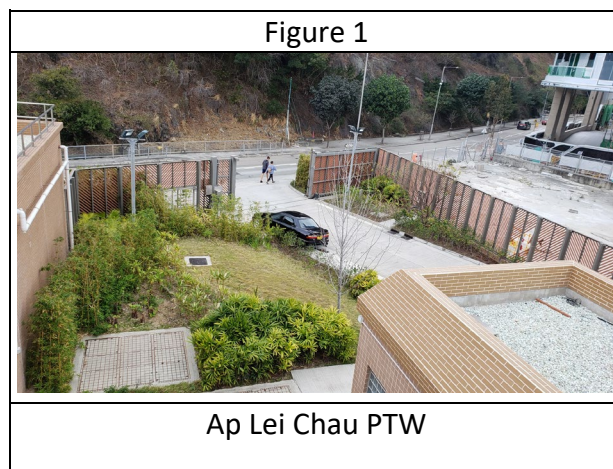
- No visible irregularities were found

- Contractor was reminded to carry out proper maintenance to plantings.

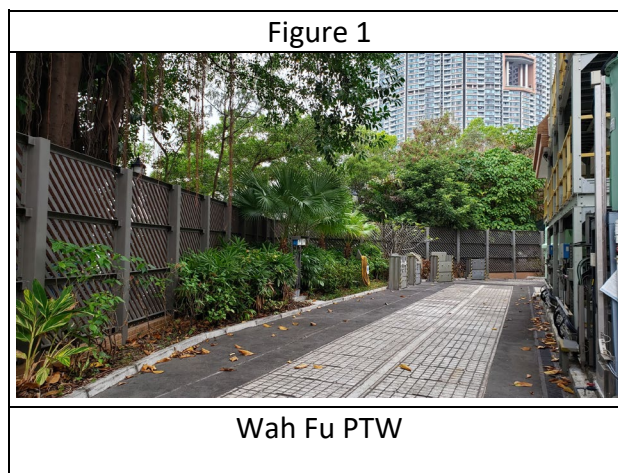
- No visible irregularities were found

- Contractor was reminded to carry out proper maintenance to plantings.

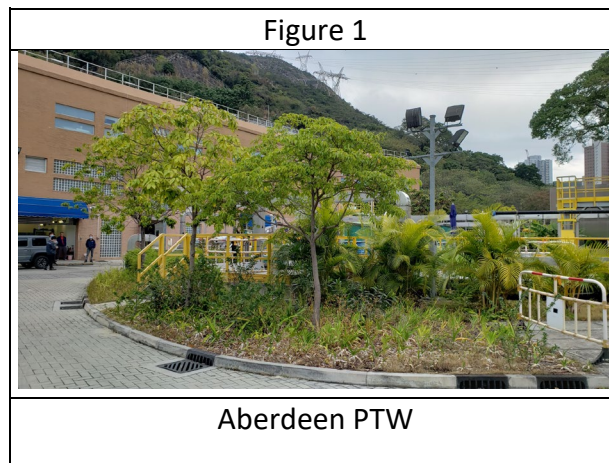
- No visible irregularities were found

- Contractor was reminded to carry out proper maintenance to plantings.

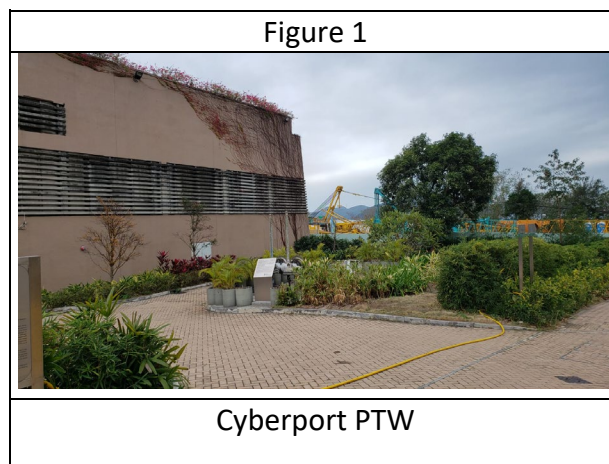
- No visible irregularities were found

- Contractor was reminded to carry out proper maintenance to plantings.

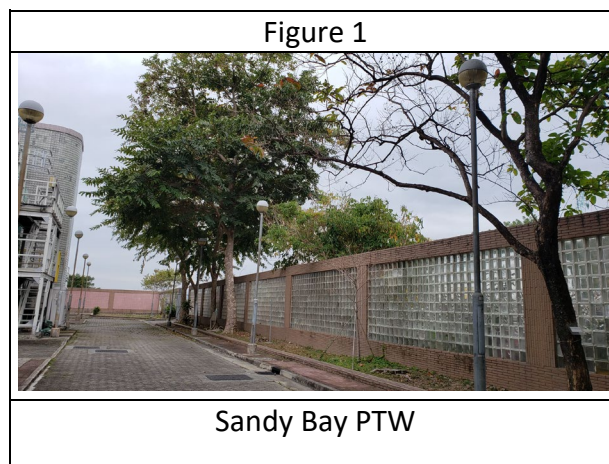
- No visible irregularities were found

- Contractor was reminded to carry out proper maintenance to plantings.

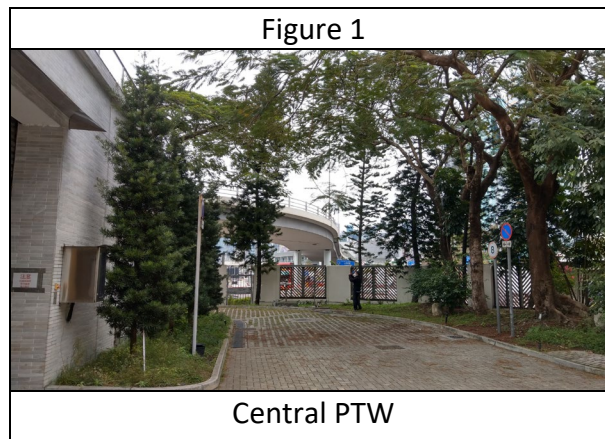
- No visible irregularities were found

- Contractor was reminded to carry out proper maintenance to plantings.

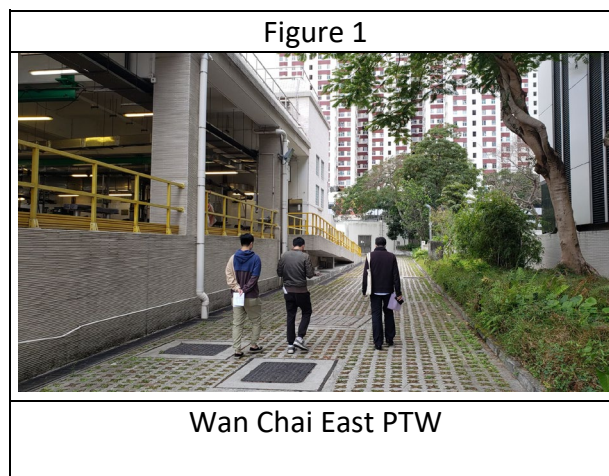
- No visible irregularities were found

- Contractor was reminded to carry out proper maintenance to plantings.

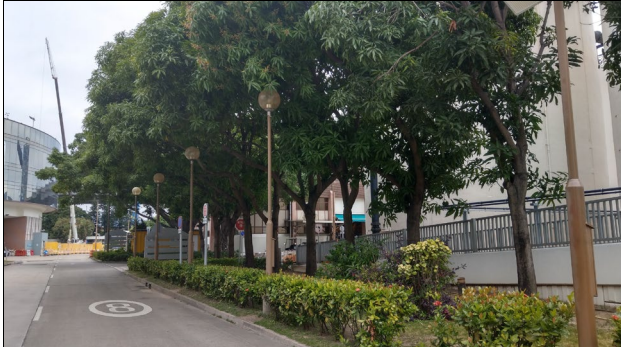
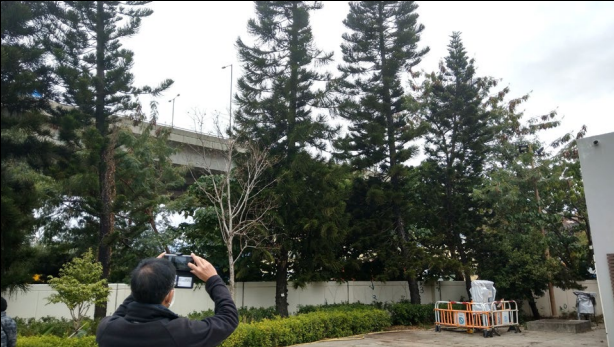
Stonecutters Island PTW	Stonecutters Island PTW

- No visible irregularities were found

- Contractor was reminded to carry out proper maintenance to plantings.
