**Landscape and Visual (L&V) Monitoring Report for  
Harbour Area Treatment Scheme Stage 2A  
(Operational Phase) (June 2022)**

Report No.: OT\_2022008

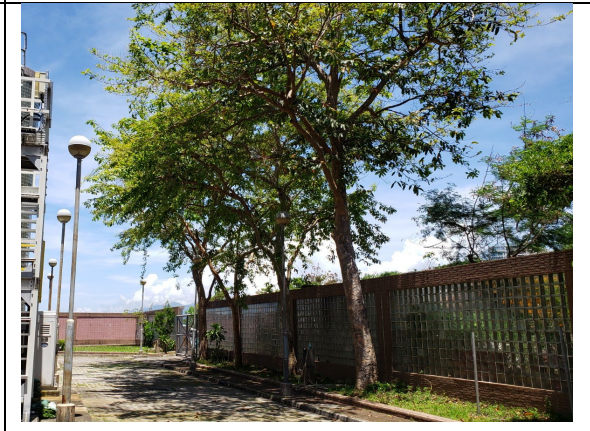
1. The health condition of marked tree (shown in Figure 2) is poor. The Contractor is recommended to carry out remedial action or tree replacement.

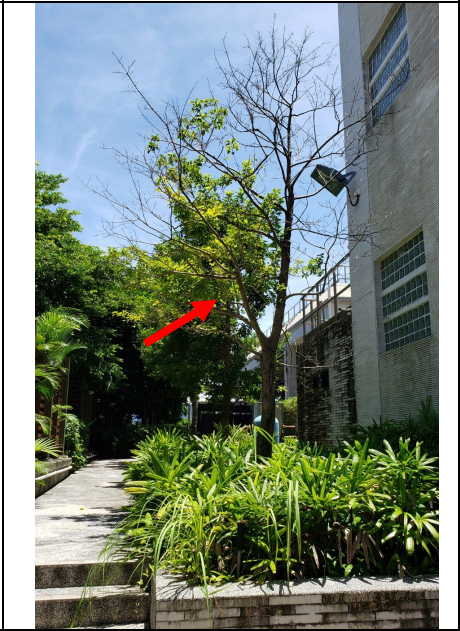
1. The health condition of marked tree (shown in Figure 2) is poor. The Contractor is recommended to carry out remedial action or tree replacement.

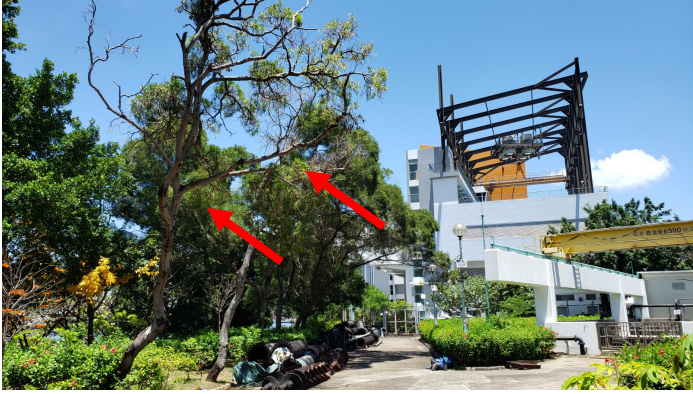
Figure 3	Figure 4	
<p style="text-align: center;">Tree T110 &amp; T109</p>

1. Some trees adjacent to trees T110 & T109 (shown in Figure 3) are severely tilted. The Contractor is recommended to carry out remedial action.
2. Some tree branches span over driveway (shown in Figure 3). The Contractor is recommended to carry out close monitoring or tree assessment.

- Vigour of some existing trees (e.g.T110 & T109) are found to be poor. Some adjacent trees are severely tilted. Close monitoring or tree risk assessment may be required.
- Die back of trees is noted. It is recommended that the maintenance party to review the situation and to remove the trees to reduce the safety risk if found to be required.
