Landscape and Visual Monitoring Report (March 2022) for Harbour Area Treatment Scheme Stage 2A (Operational Phase)

**Landscape and Visual (L&V) Monitoring Report for
Harbour Area Treatment Scheme Stage 2A
(Operational Phase) (March 2022)**

Report No.: OT_2022004

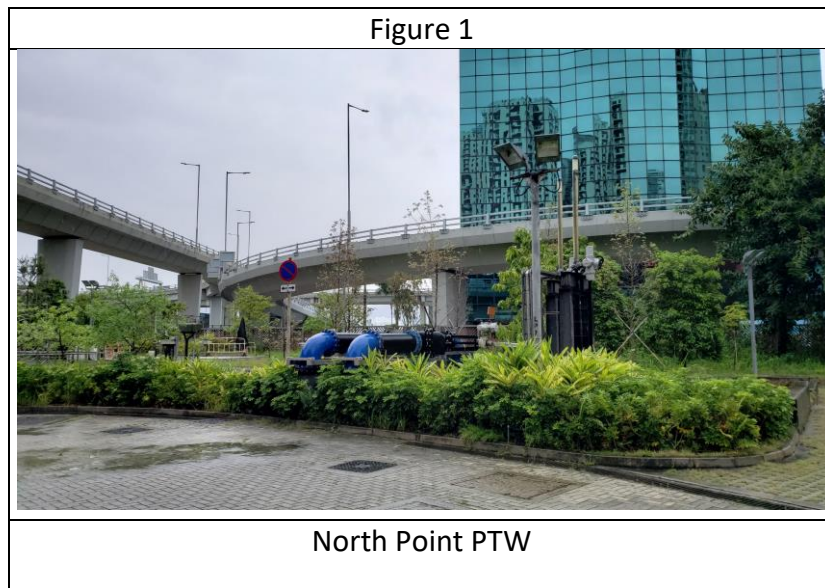
Landscape and Visual Impact Assessment Checklist for Site Audit – North Point PTW

- No visible irregularities were found

- Contractor was reminded to carry out proper maintenance to plantings.

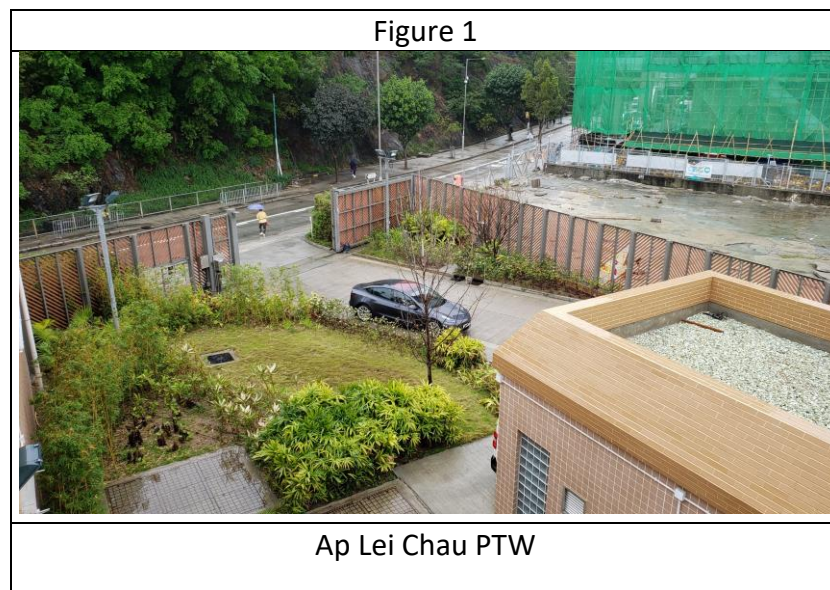
Landscape and Visual Impact Assessment Checklist for Site Audit – Ap Lei Chau PTW

- No visible irregularities were found

- Contractor was reminded to carry out proper maintenance to plantings and recommended to increase the frequency of watering.

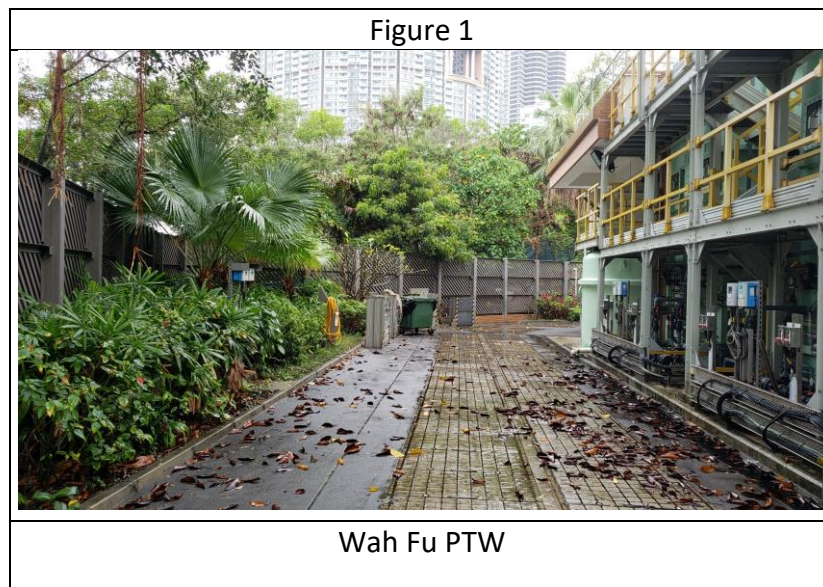
Landscape and Visual Impact Assessment Checklist for Site Audit – Wa Fu PTW

- No visible irregularities were found

- Contractor was reminded to carry out proper maintenance to plantings.

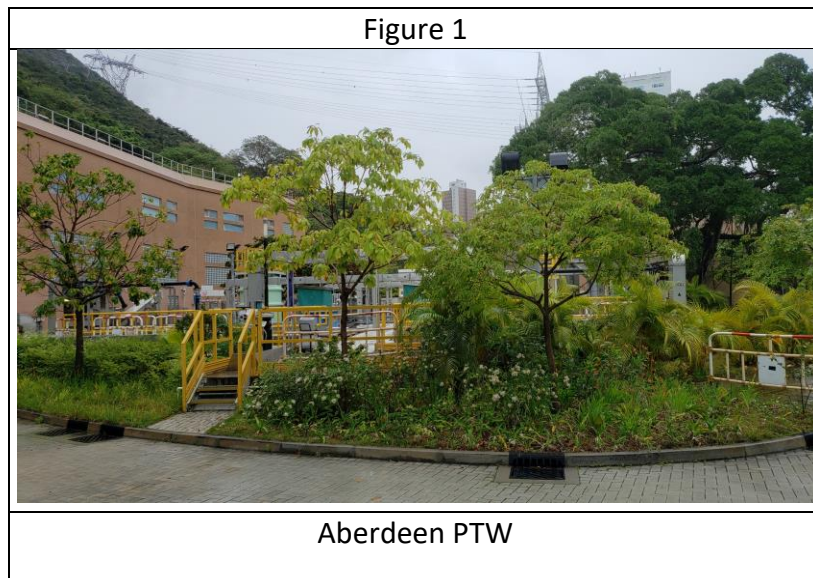
Landscape and Visual Impact Assessment Checklist for Site Audit – Aberdeen PTW

- No visible irregularities were found

- Contractor was reminded to carry out proper maintenance to plantings.

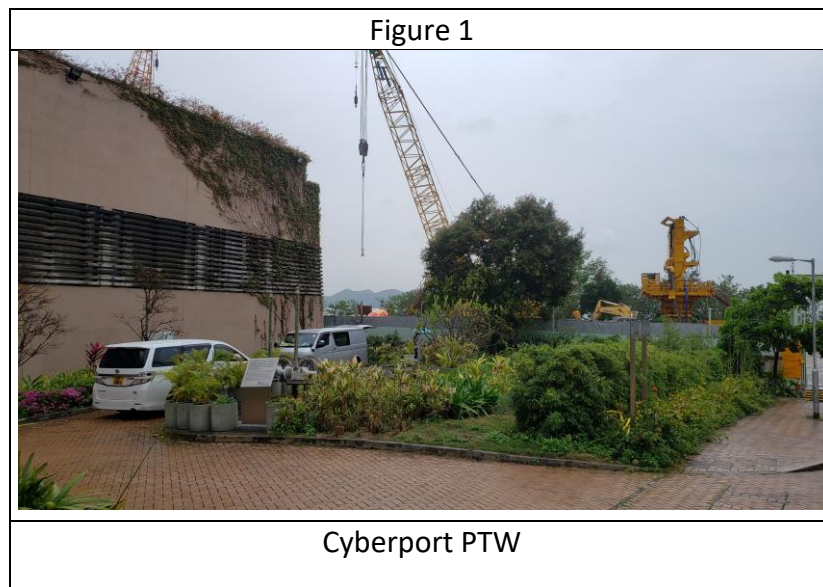
Landscape and Visual Impact Assessment Checklist for Site Audit – Cyberport PTW

- No visible irregularities were found

- Contractor was reminded to carry out proper maintenance to plantings and removal of weeds.

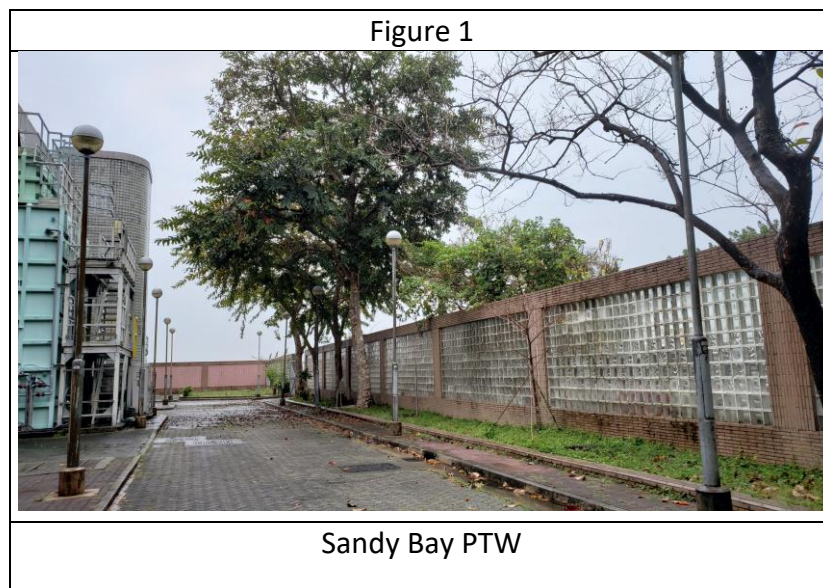
Landscape and Visual Impact Assessment Checklist for Site Audit – Sandy Bay PTW

- No visible irregularities were found

- Contractor was reminded to carry out proper maintenance to plantings and recommended to increase the frequency of watering.

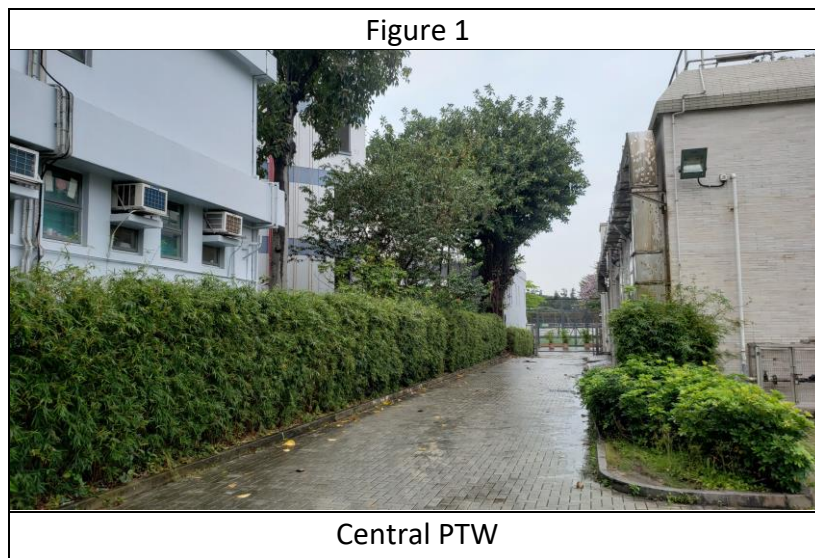
Landscape and Visual Impact Assessment Checklist for Site Audit – Central PTW

- No visible irregularities were found

- Contractor was reminded to carry out proper maintenance to plantings.

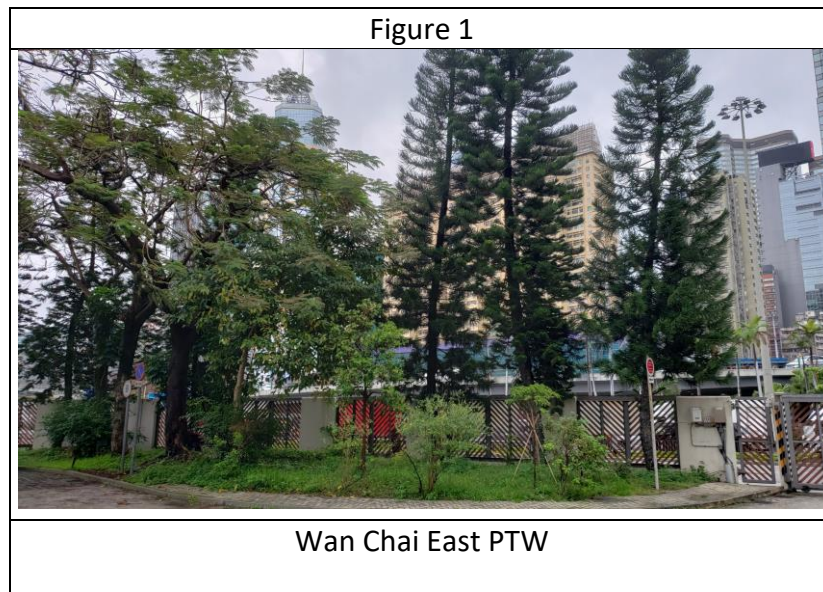
Landscape and Visual Impact Assessment Checklist for Site Audit – Wan Chai PTW

- No visible irregularities were found

- Contractor was reminded to carry out proper maintenance to plantings and recommended to provide adequate protection to trees adjacent to works area.

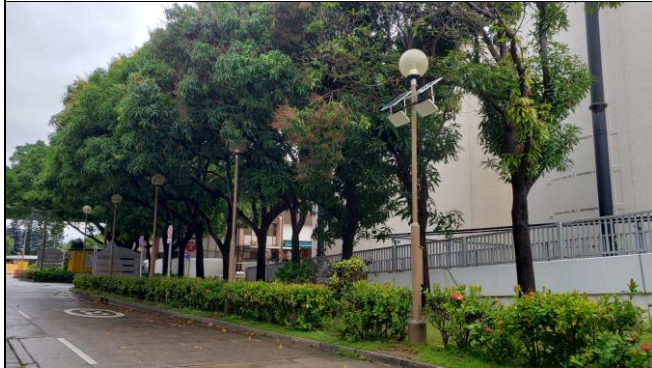
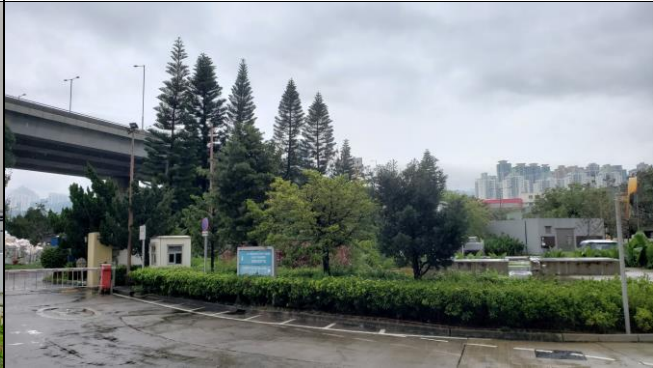
Figure 1	Figure 2

- No visible irregularities were found

- Contractor was reminded to carry out proper maintenance to plantings and recommended to check any broken branches at trees along roadside.
