**Landscape and Visual (L&V) Monitoring Report for
Harbour Area Treatment Scheme Stage 2A
(Operational Phase) (May 2022)**

Report No.: OT_2022007

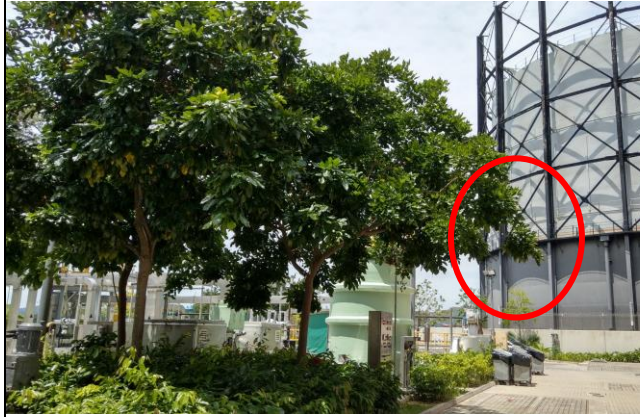
- Contractor was reminded to carry out proper maintenance to plantings and recommended to closely monitor the conditions of the pruned trees. It is also recommended to increase the frequency of watering.
- Some tree branches span over driveway as shown in Figure 2. It is recommended that maintenance party to review if pruning is required.

Aberdeen PTW	<ol style="list-style-type: none"> 1. Carry out proper maintenance to plantings 2. Increase the frequency of watering 3. Closely monitor the conditions of the pruned trees 4. Review if pruning is required for tree with branches span over driveway by the maintenance party

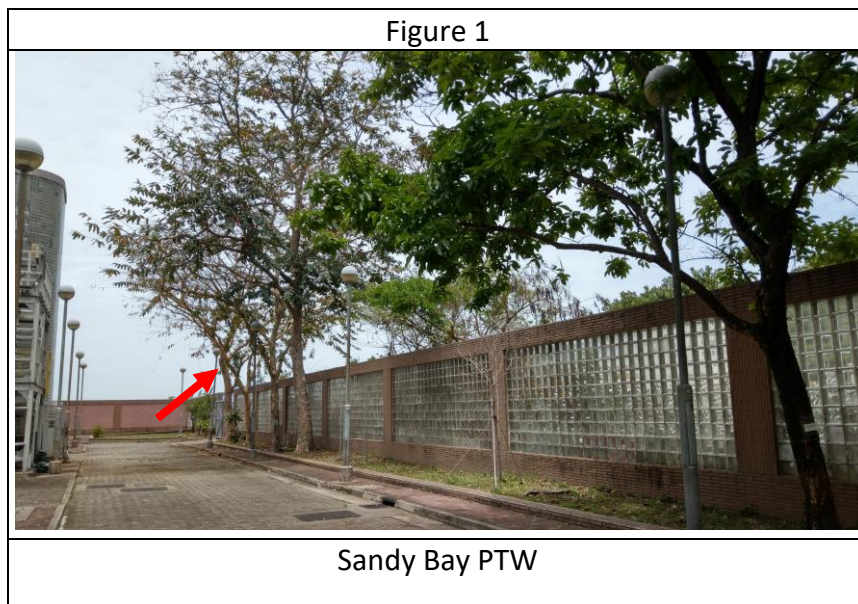
- Contractor was reminded to carry out proper maintenance to plantings and recommended to increase the frequency of watering.
- It was noted that leaves shredded and foliage's colour turns yellow for trees at inner side as shown in Figure 1. Continuous monitoring of the tree condition is required.
