**Landscape and Visual (L&V) Monitoring Report for
Harbour Area Treatment Scheme Stage 2A
(Operational Phase) (November 2022)**

Report No.: OT_2022015

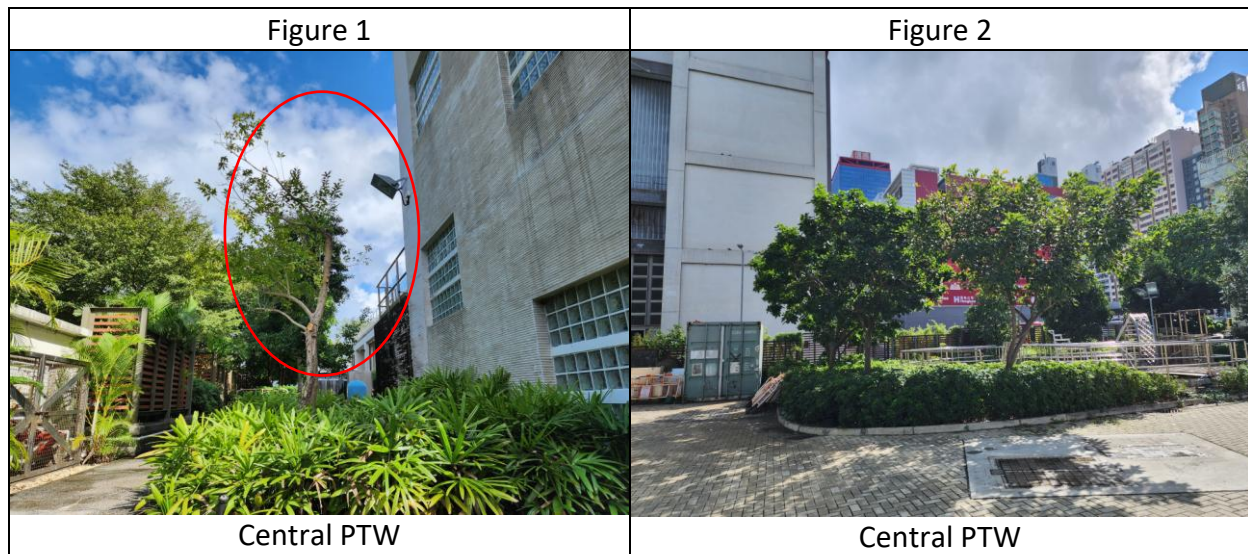
1. Noticed the dead branches of the tree at entrance area have been removed (Figure 1).

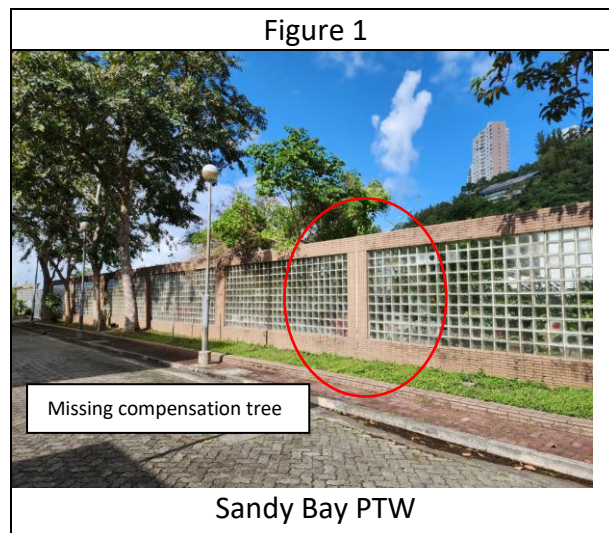
1. Follow up rectification item no.1 on 29/07/2022, the marked tree was removed but the compensation tree is missing. The Contractor is reminded to carry out tree replacement.

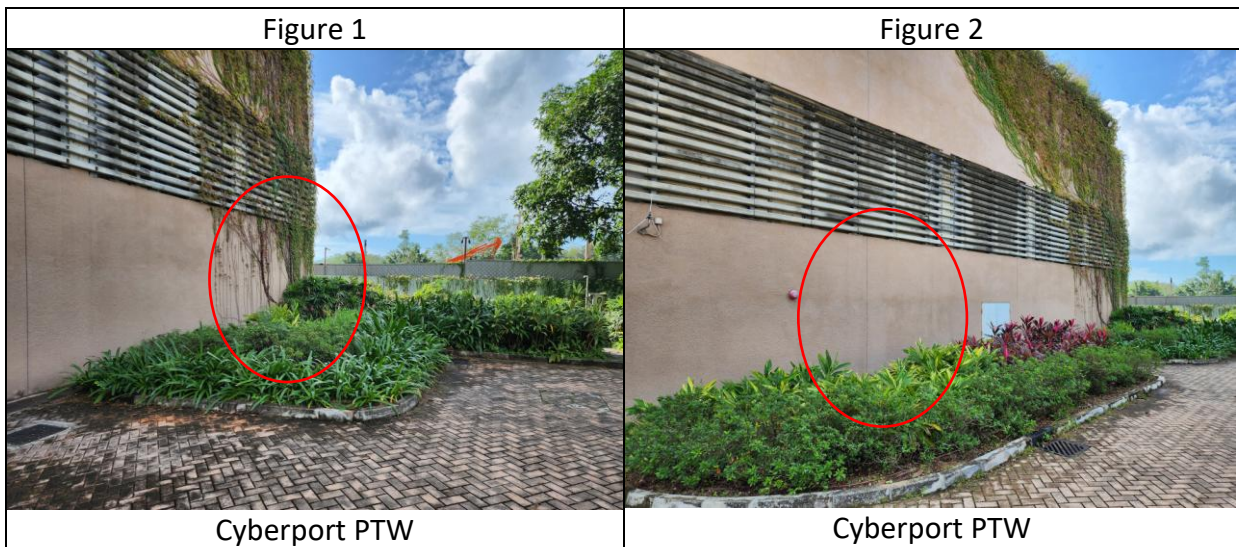
1. Noticed the dead tree of observation item on 26/09/2022 inside the planting area have been removed (Figures 1 & 2).

1. The contractor is recommended to replant the trees as early as possible for compensating the removal of dead tree

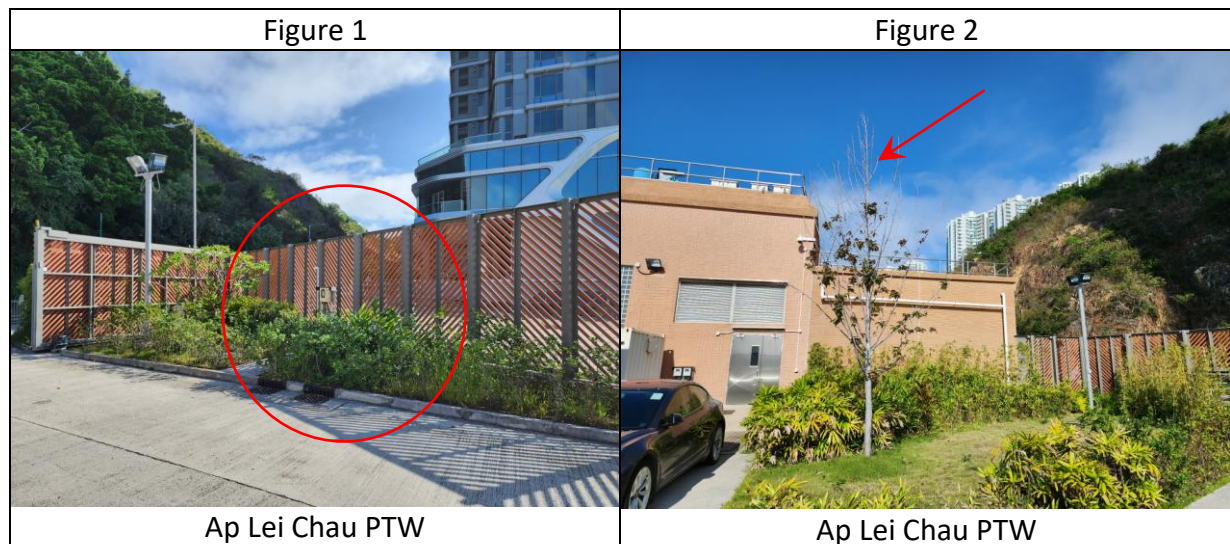
1. Noticed the dead tree of observation item on 29/08/2022 at the entrance area has been removed (shown in Figure 1).

1. Follow up observation item no. on 26/10/2022, die back on twigs was observed at entrance area (shown in Figure 2). It is recommended that maintenance party to provide trimming to the dead twigs.
2. The contractor is recommended to replant the trees as early as possible for compensating the removal of dead tree

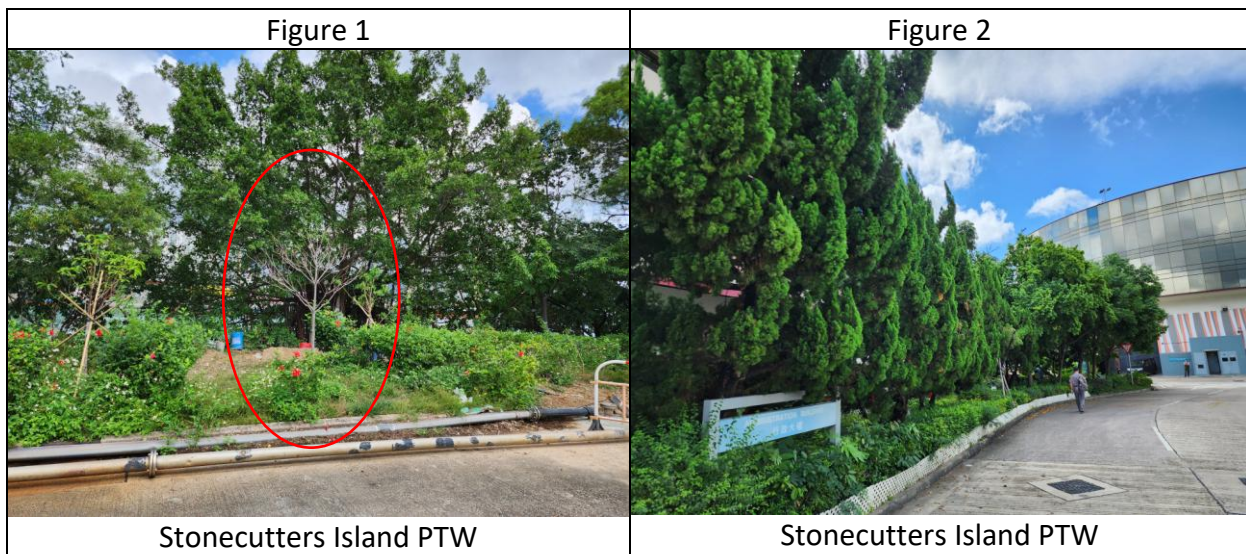
1. Follow up observation item no. 1 on 29/08/2022, Poor health is observed for replacement tree (shown in Figure 1). It is recommended that maintenance party to review if replacement is required.
