**Landscape and Visual (L&V) Monitoring Report for
Harbour Area Treatment Scheme Stage 2A
(Operational Phase) (October 2022)**

Report No.: OT_2022013

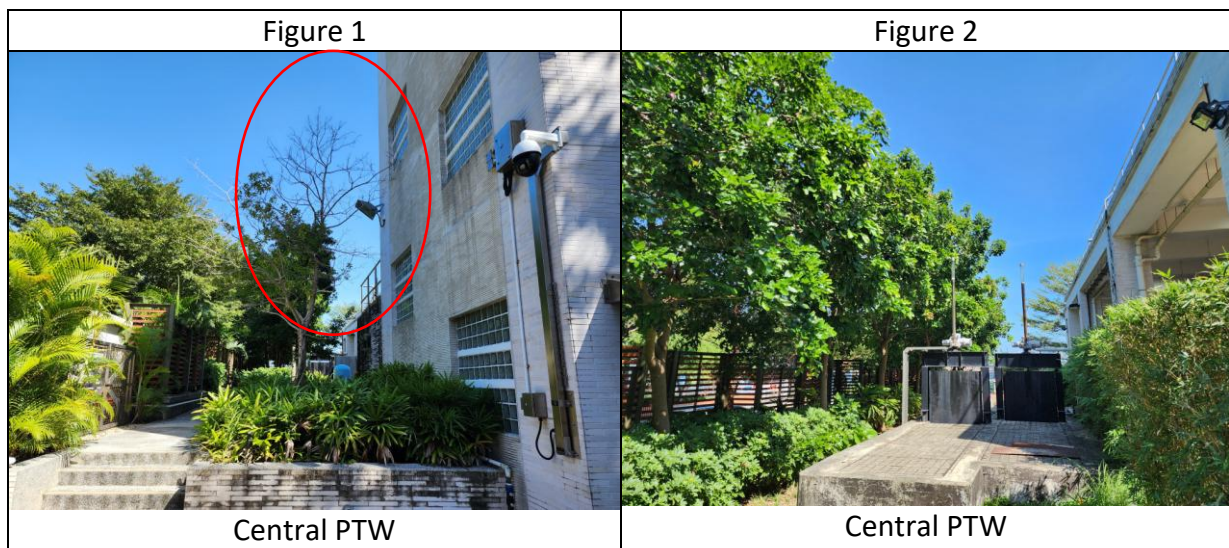
1. Contractor was reminded to keep maintenance and pay attention to the plant conditions on the marked tree (Figure 1) and recommended to further increase the frequency of watering in the period of dry weather.

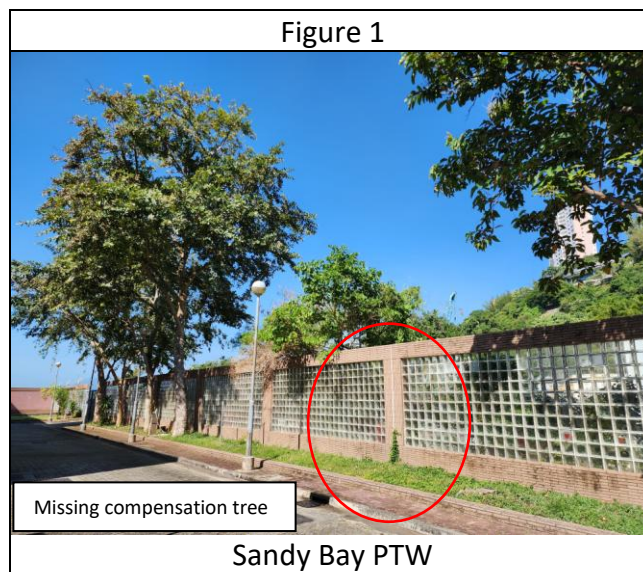
1. Follow up rectification item no.1 on 29/07/2022, the marked tree was removed but the compensation tree is missing. The Contractor is reminded to carry out tree replacement.

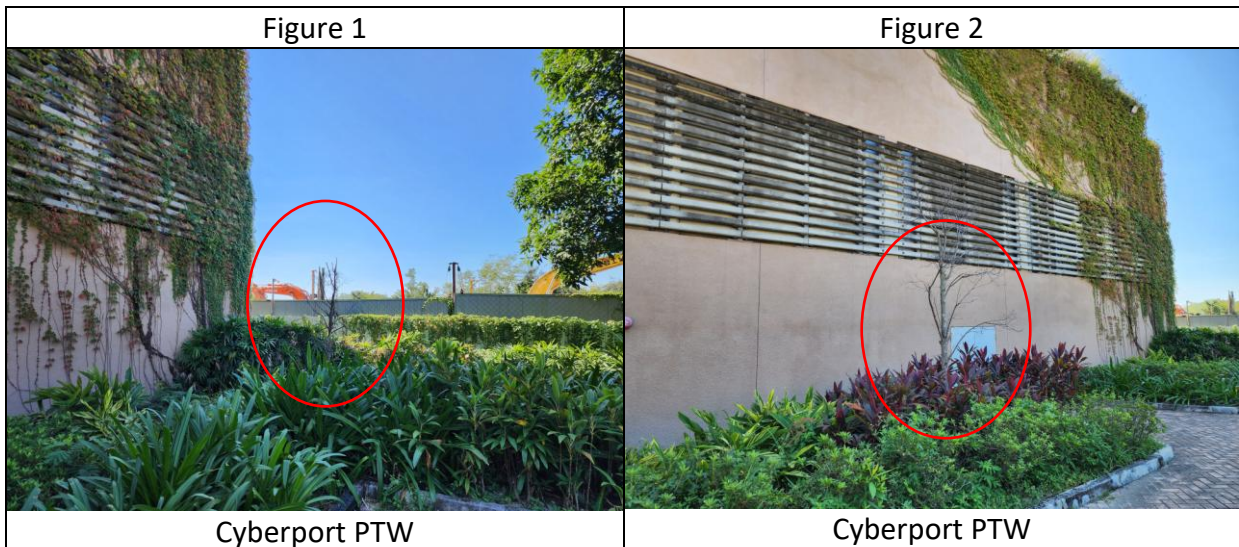
1. Follow up observation item no. on 26/09/2022, dead trees were observed (Figures 1 & 2) inside the planting area. It is recommended that maintenance party to review if replacement is required.

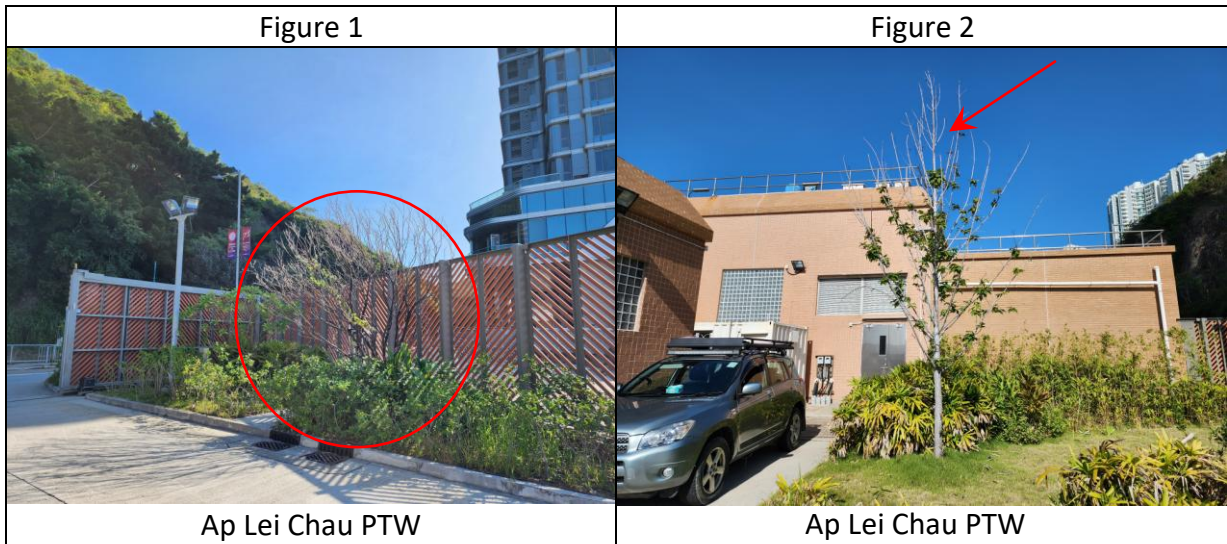
1. Follow up observation item no. on 29/08/2022, one dead tree was observed at entrance area (shown in Figure 1). It is recommended that maintenance party to review if replacement is required.

1. Die back on twigs was observed at entrance area (shown in Figure 2). It is recommended that maintenance party to provide trimming to the dead twigs.

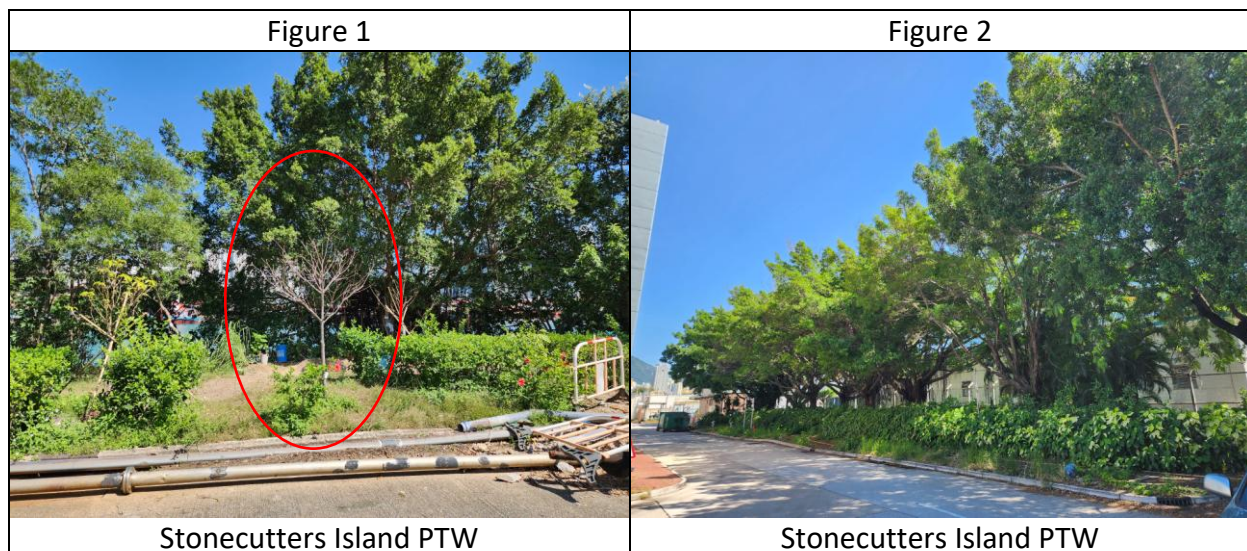
1. Follow up observation item no. 1 on 29/08/2022, Poor health is observed for replacement tree (shown in Figure 1). It is recommended that maintenance party to review if replacement is required.
