**Landscape and Visual (L&V) Monitoring Report for  
Harbour Area Treatment Scheme Stage 2A  
(Operational Phase) (September 2022)**

Report No.: OT\_2022012

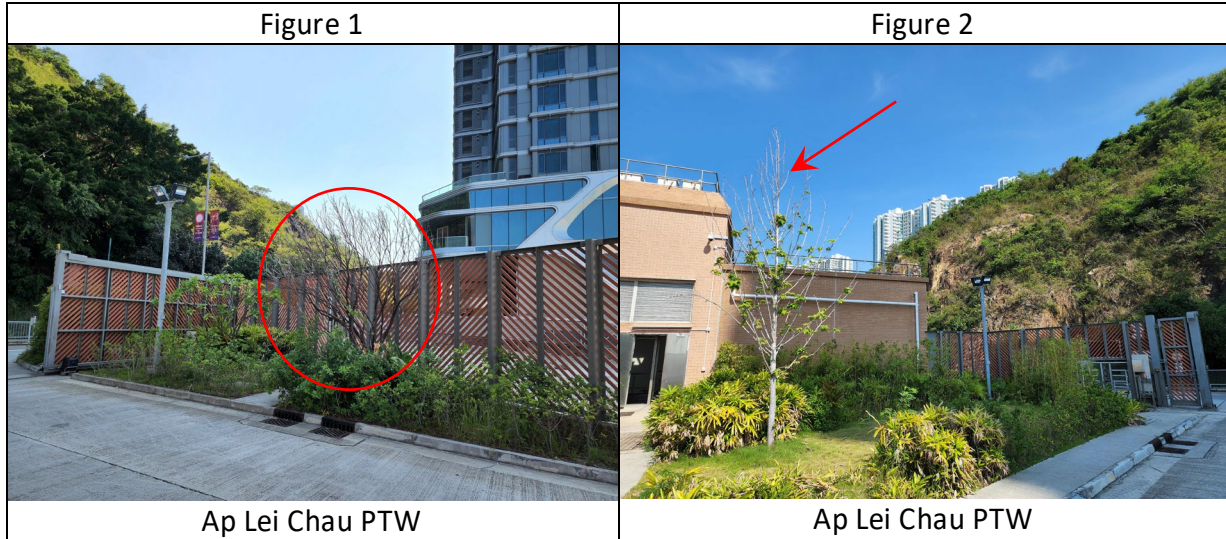
1. Follow up observation item no. on 29/08/2022, one dead tree was observed at entrance area (shown in Figure 1). It is recommended that maintenance party to review if replacement is required.

1. Die back on twigs was observed at entrance area (shown in Figure 2). It is recommended that maintenance party to provide trimming to the dead twigs.

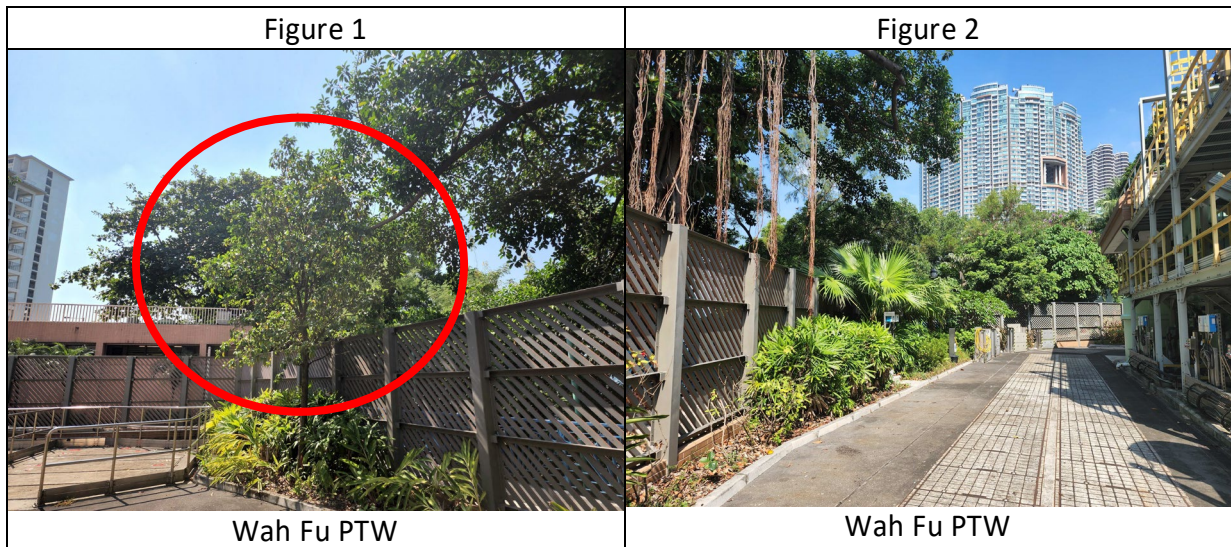
1. Follow up observation item no. on 29/08/2022, dead leaves were observed at the marked tree (as shown in Figure 1). It is recommended that maintenance party to review if pruning is required.

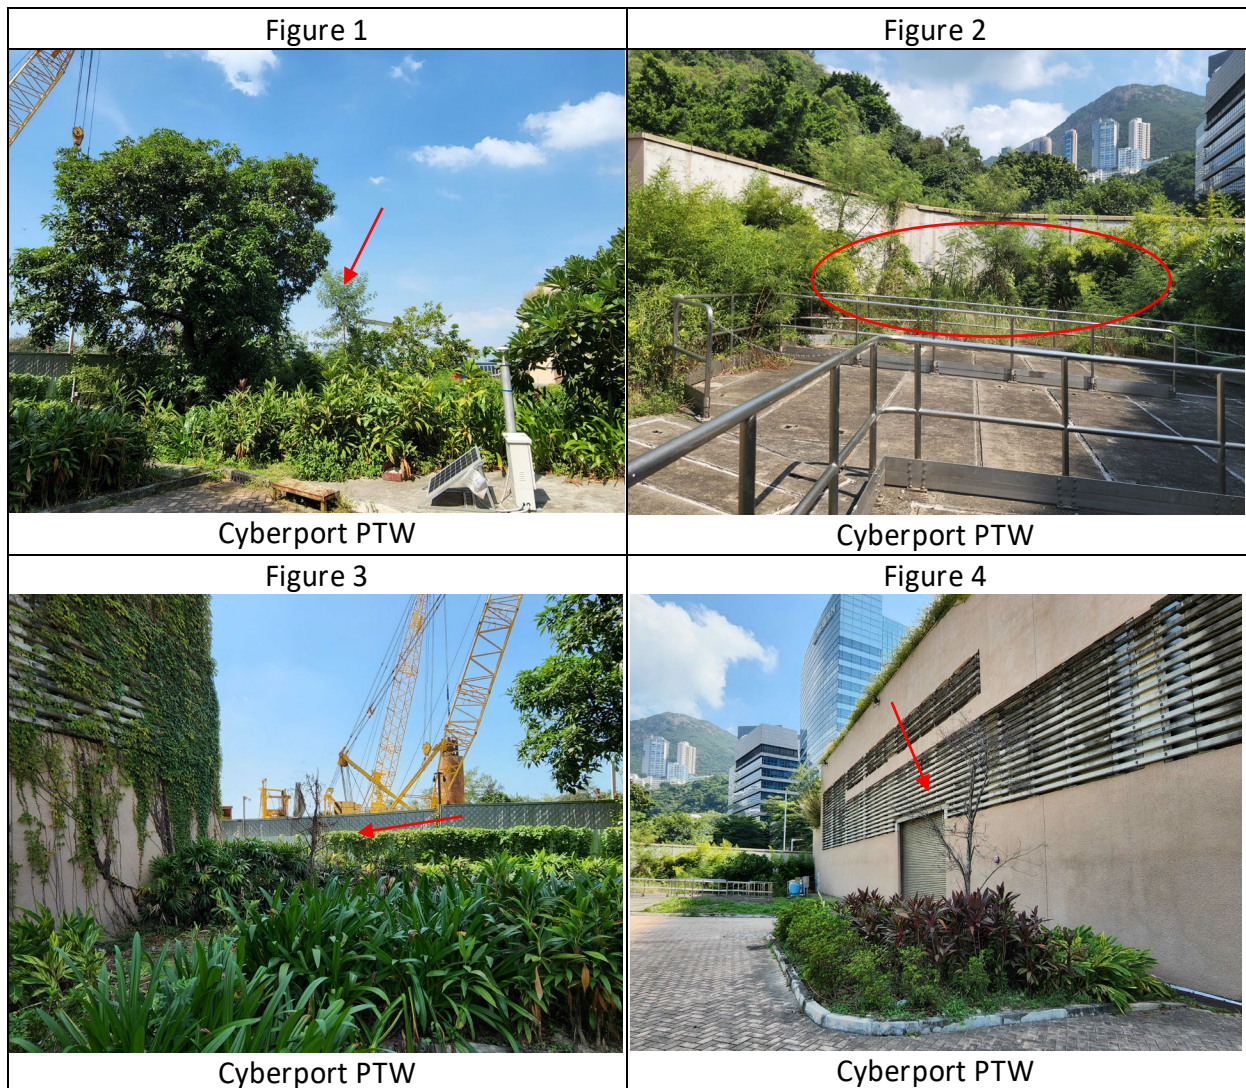
1. Follow up observation item no. on 29/08/2022, weeds and undesirable species (*Leucaena leucocephala*) were observed among shrubs planting (Figure 1 & 2). It is recommended to carry out necessary weeding and maintenance work.

1. Dead trees were observed (Figures 3 & 4) inside the planting area. It is recommended that maintenance party to review if replacement is required.

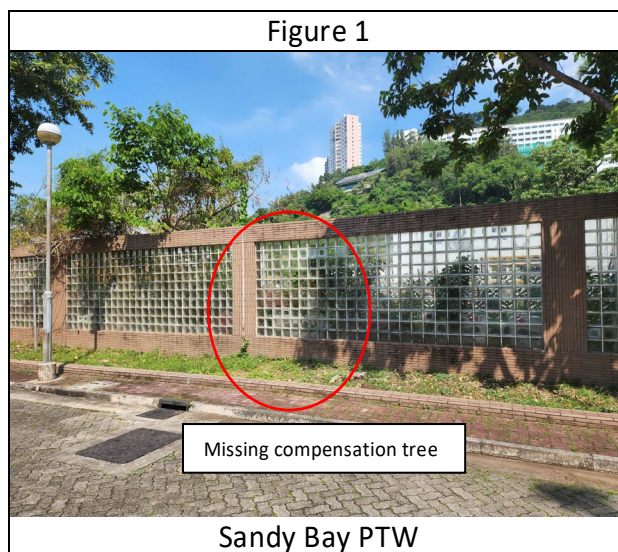
1. Follow up rectification item no.1 on 29/07/2022, the marked tree was removed but the compensation tree is missing. The Contractor is reminded to carry out tree replacement.

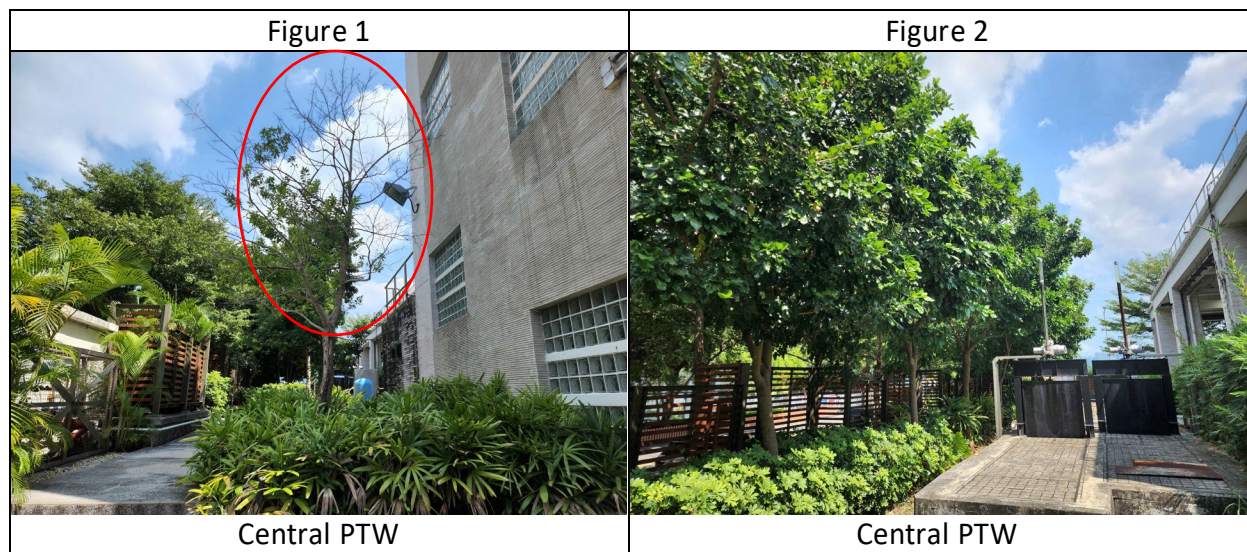
1. Contractor was reminded to keep maintenance and pay attention to the plant conditions on the marked tree (Figure 1) and recommended to further increase the frequency of watering in the period of extreme hot weather.

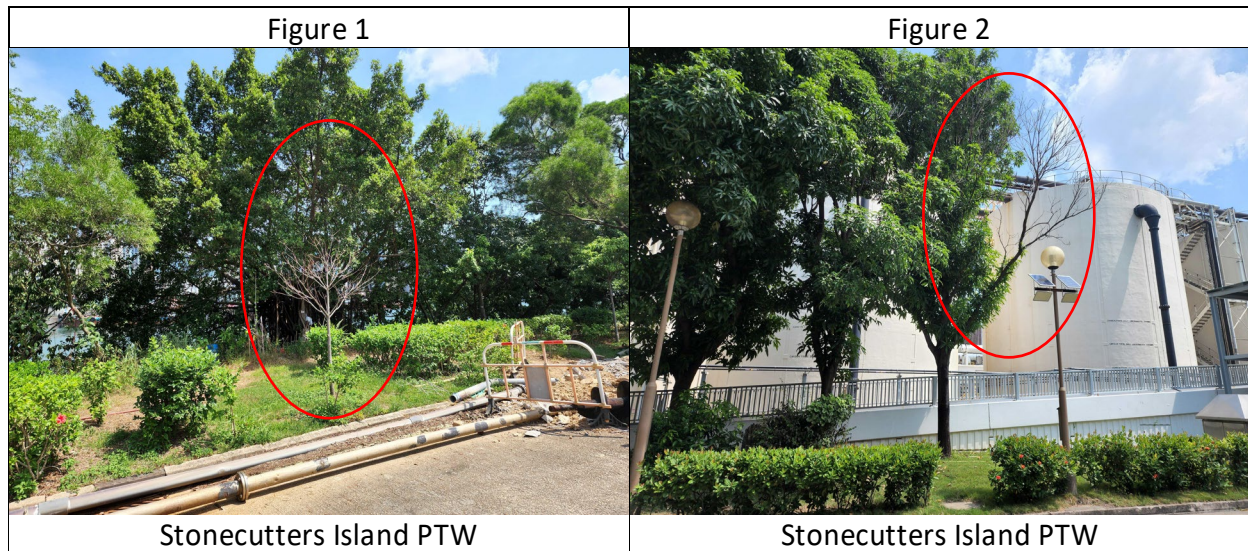
1. Follow up observation item no. 1 on 29/08/2022, Poor health is observed for replacement tree (shown in Figure 1). It is recommended that maintenance party to review if replacement is required.
2. Follow up observation item no. 2 on 29/08/2022, Dead branches (shown in Figure 2) with fungal growth are observed. Pruning of dead branches is recommended.
3. Some existing trees adjacent to T110 & T109 are still found severely tilted and span over driveway (shown in Figure 3). It is recommended that maintenance party to review if pruning is required.
