Protection of concrete for sewage installations and an accelerated test on protection systems

Drainage Services Department Research and Development Forum 2012 27 Nov 2012 - Sustainable Drainage Design

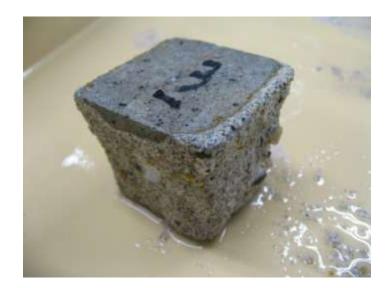
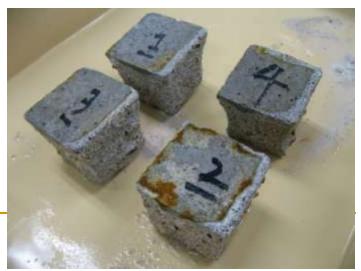
Mortar cubes (Control group)

- Samples without coatings had severe damage after 14 days.
- The dimensions at the bottom of the cubes reduced from 50mm × 50mm to approx. 40mm × 40mm.
- 25% Weight loss.

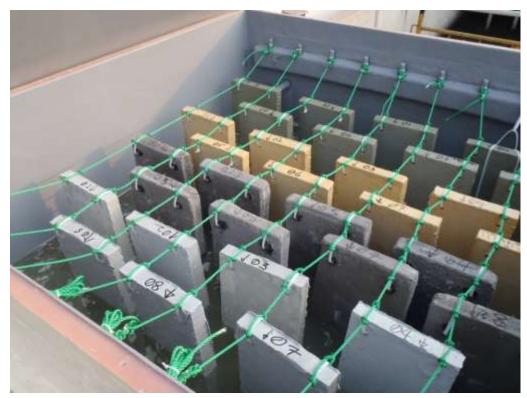
- Half of the plate above water level.
- Area above the water/ scum stayed acidic (pH 0~2)
- Area covered with scum turned alkaline (pH >8).

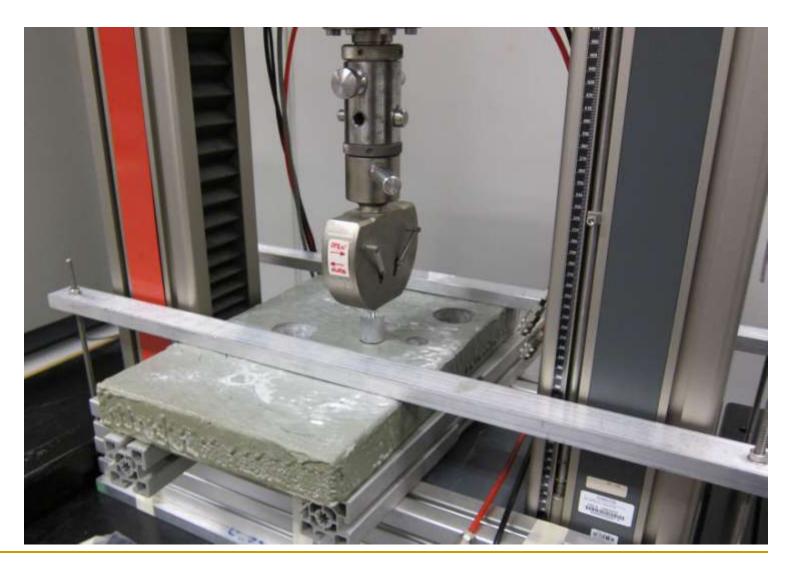
Pull test

Coating I	MPa	Failure interface
Control #1	1.06	Coating - Adhesive
Control #2	1.04	Primer - Coating
Control #3	0.68	Concrete - Primer
Coating I	MPa	Failure interface
Batch1 #1	1.77	Primer - Coating
Batch1 #2	1.91	Primer - Coating
Batch1 #3	2.37	Concrete - Primer
Coating I	MPa	Failure interface
Batch2 #1	0.79	Concrete - Primer
Batch2 #2	0.78	Concrete - Primer
Batch2 #3	0.72	Primer - Coating

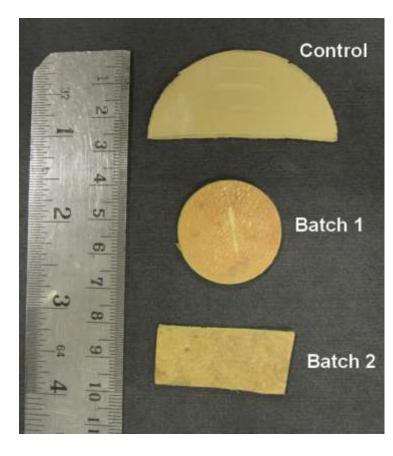
Samples became more wear resistant.

Coating I	Weight loss (gram/day)
Control	0.060
Batch 1	0.036
Batch 2	0.010

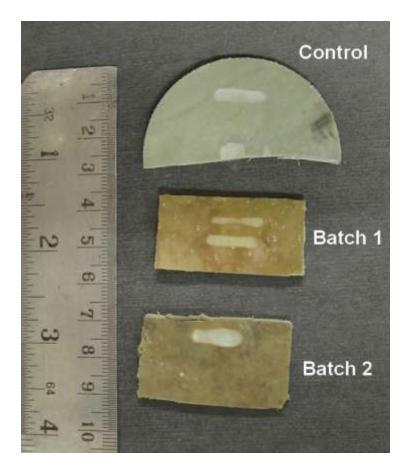
Samples became less wear resistant.

Coating II	Weight loss (gram/day)
Control	0.125
Batch 1	0.106
Batch 2	0.298

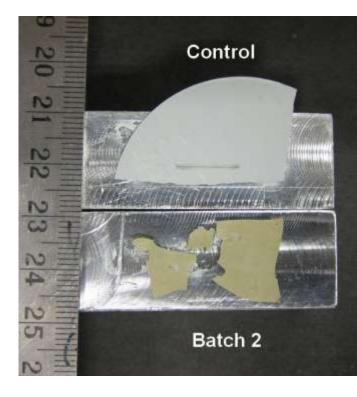
Batch 1 & 2 samples fractured into pieces during wear test.

Coating III	Weight loss (gram/day)
Control	0.017
Batch 1	n/a
Batch 2	n/a
