**Landscape and Visual (L&V) Monitoring Report for
Harbour Area Treatment Scheme Stage 2A
(Operational Phase) (August 2022)**

Report No.: OT_2022011

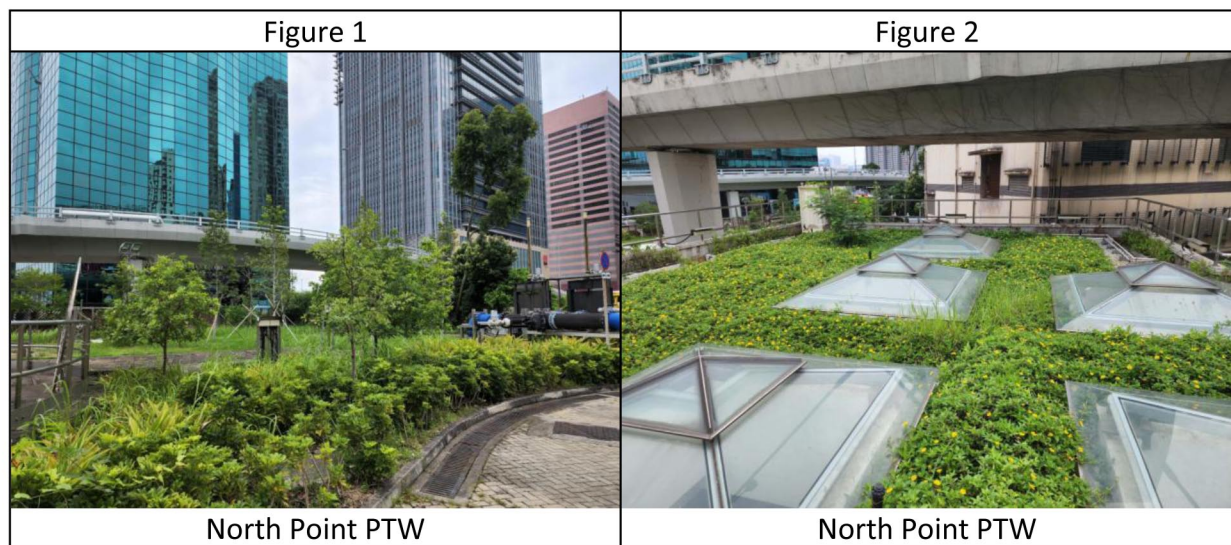
- Contractor was reminded to carry out proper maintenance to plantings and was recommended to further increase the frequency of watering in the period of extreme hot weather.

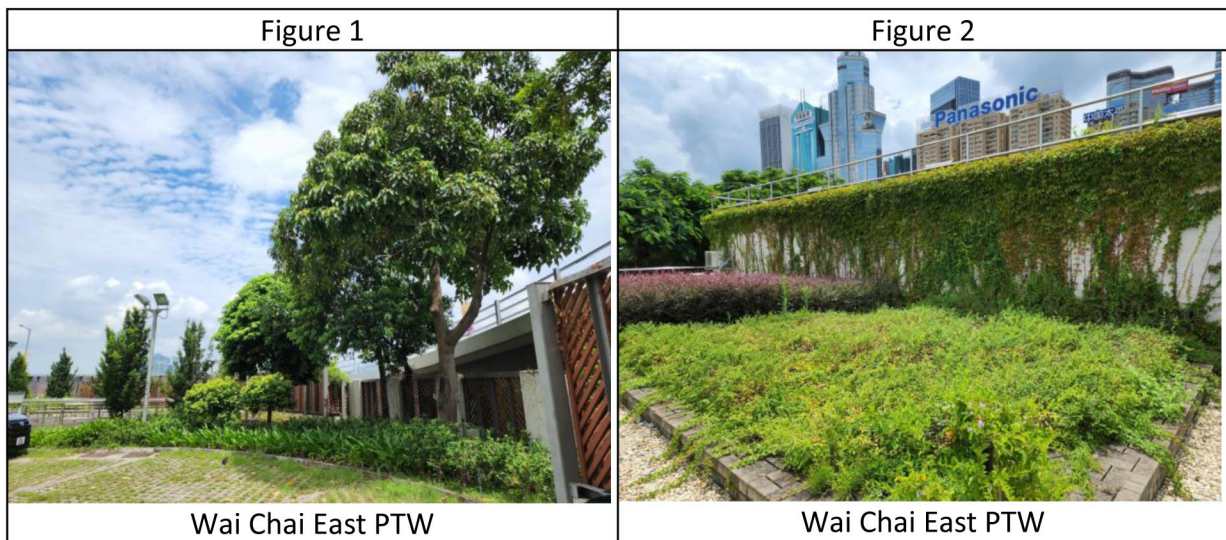
1. Contractor was reminded to carry out proper maintenance to plantings and recommended to further increase the frequency of watering in the period of extreme hot weather.
