**Landscape and Visual (L&V) Monitoring Report for  
Harbour Area Treatment Scheme Stage 2A  
(Operational Phase) (June 2022)**

Report No.: OT\_2022008

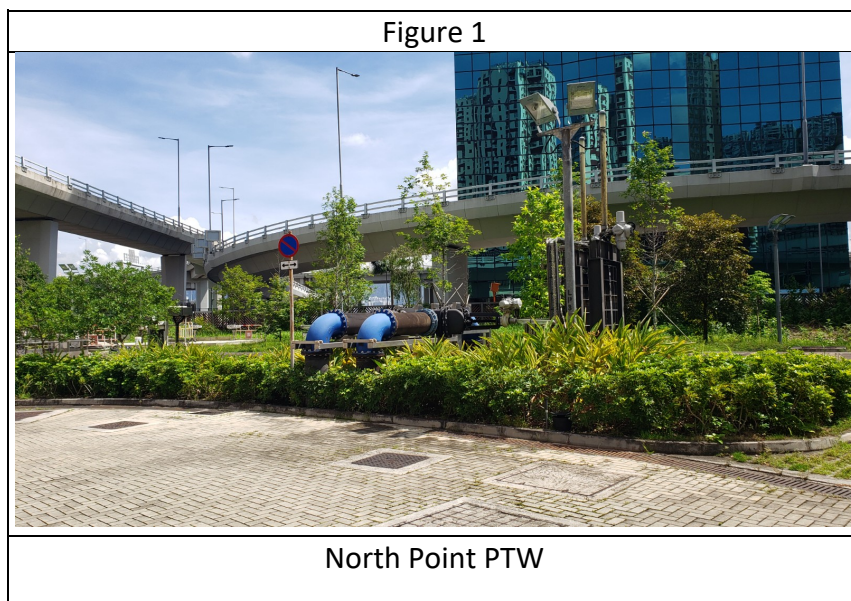
- No visible irregularities were found

- Contractor was reminded to carry out proper maintenance to plantings and was recommended to increase the frequency of watering.

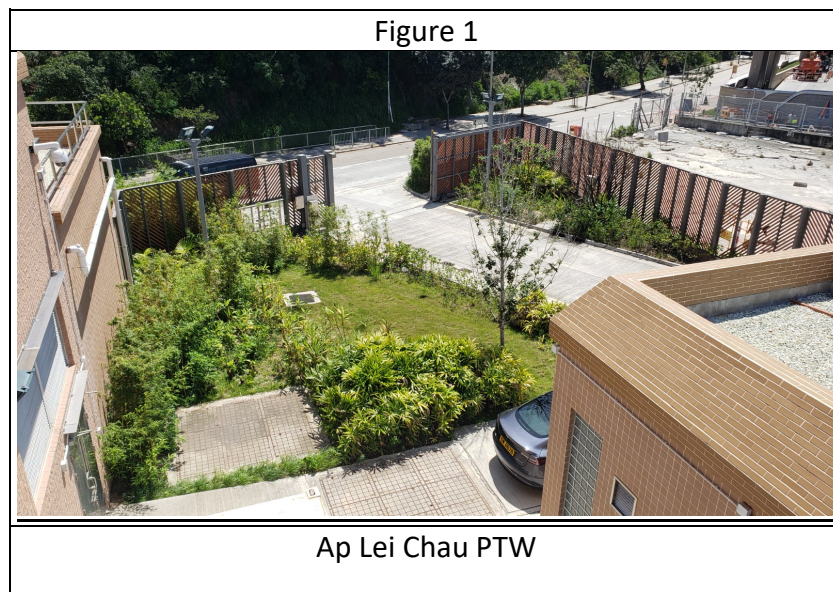
- No visible irregularities were found

- Contractor was reminded to carry out proper maintenance to plantings and recommended to increase the frequency of watering.

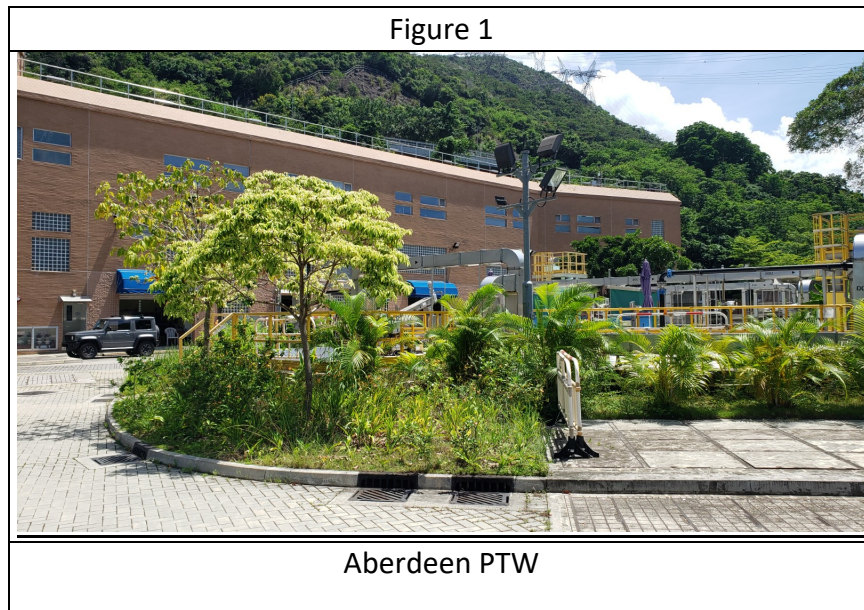
- No visible irregularities were found

- Contractor was reminded to carry out proper maintenance to plantings and recommended to closely monitor the conditions of the pruned trees. It is also recommended to increase the frequency of watering.
- Pruning of trees has been followed up as previously recommended.

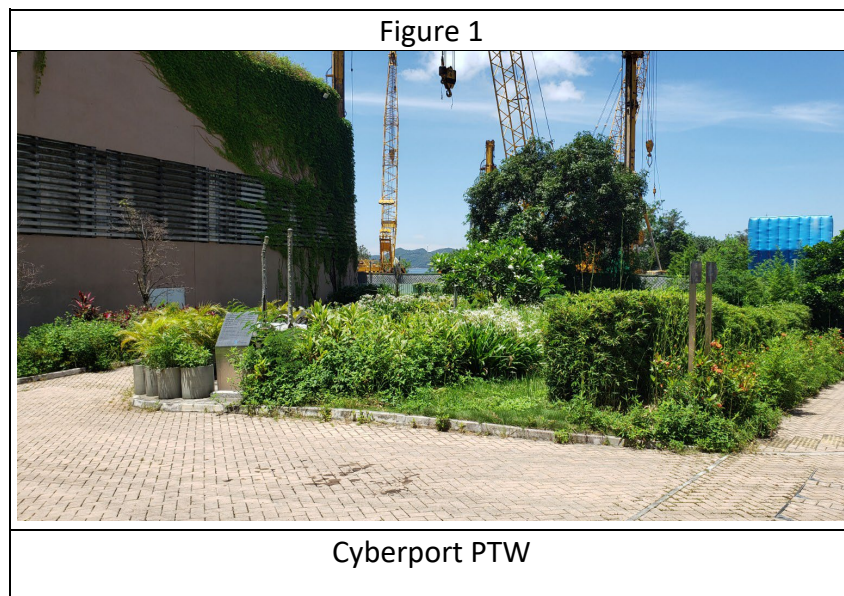
- No visible irregularities were found

- The general housekeeping has been improved. Contractor was recommended to increase the frequency of watering. It is also recommended to increase the maintenance of pot plants.

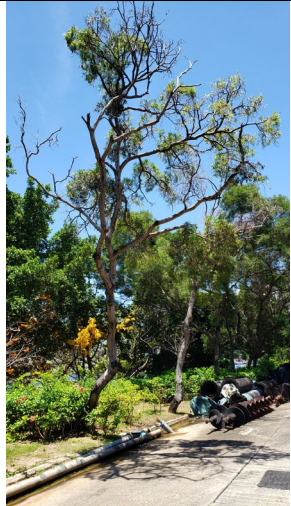
1. Some trees adjacent to trees T110 & T109 (shown in Figure 3) are severely tilted. The Contractor is recommended to carry out remedial action.
2. Some tree branches span over driveway (shown in Figure 3). The Contractor is recommended to carry out close monitoring or tree assessment.
