**Landscape and Visual (L&V) Monitoring Report for
Harbour Area Treatment Scheme Stage 2A
(Operational Phase) (May 2022)**

Report No.: OT_2022007

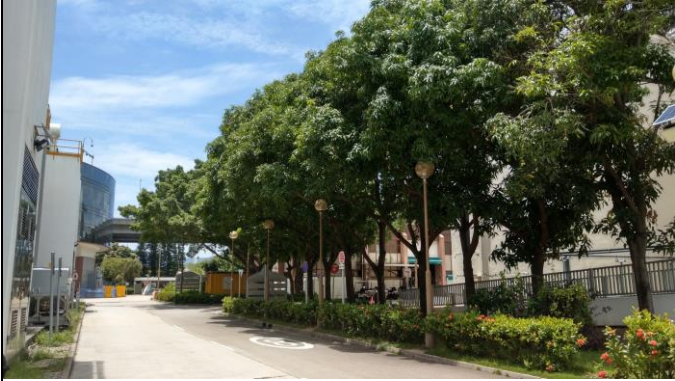
- Vigour of some existing trees (e.g.T110 & T109) as shown in Figure 3 are found to be poor. Close monitoring or tree risk assessment may be required.
- Die back of trees as shown in Figure 4 is noted. It is recommended that the maintenance party to review the situation and to remove the trees to reduce the safety risk if found to be required.
