Protection of concrete for sewage installations and an accelerated test on protection systems

Drainage Services Department Research and Development Forum 2012 27 Nov 2012 - Sustainable Drainage Design

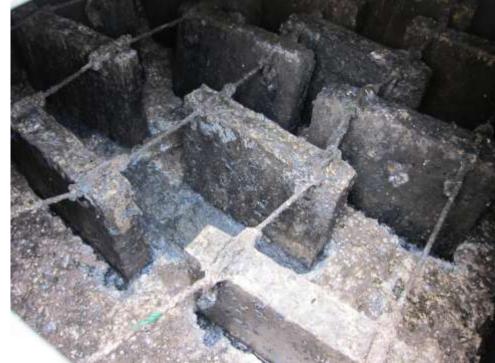
pH on sample surfaces

- Half of the plate above water level.
- Area above the water/ scum stayed acidic (pH 0~2)
- Area covered with scum turned alkaline (pH >8).
